Victor Valley College 2015 Facilities Master Plan Update

Introduction

Victor Valley College Facilities Master Plan Update , March, 2015 Status Report

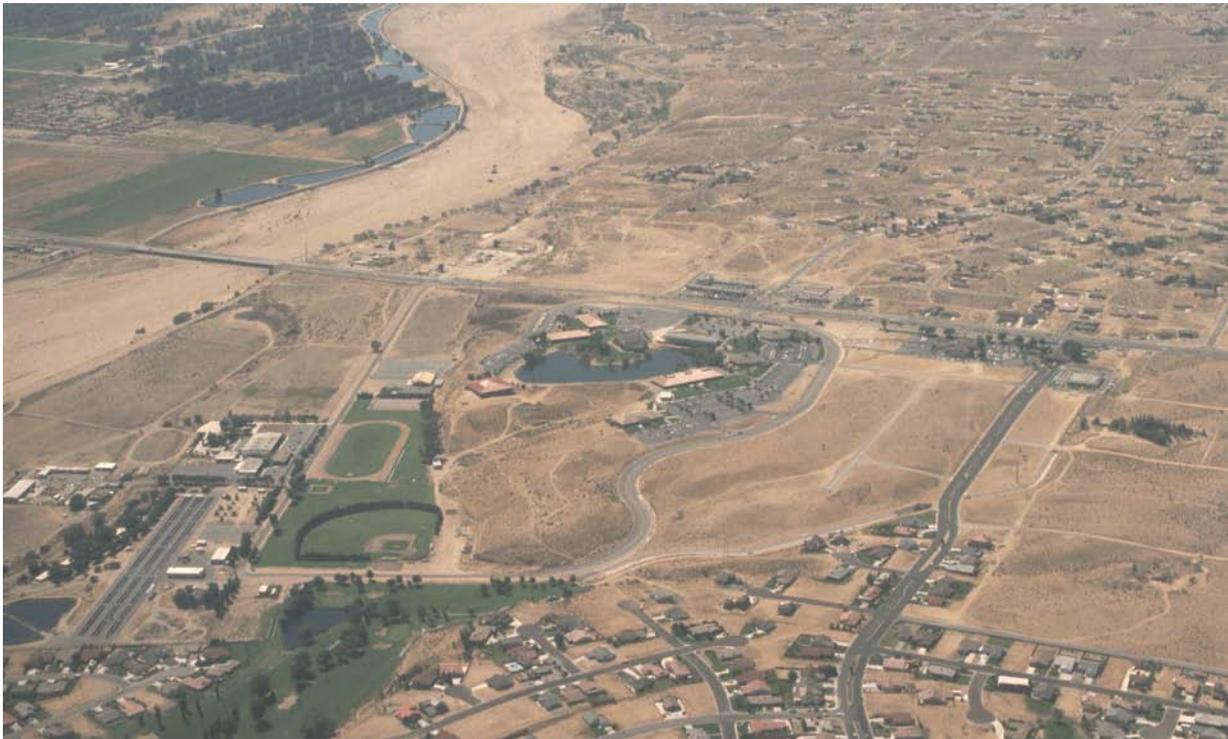
Aerial Photo of Victor Valley College looking south, taken by the Author in 1998. The was an over flight organized by Antelope Valley College who invited state chancellor’s office officials to the High Desert Region to “see for themselves” the recent growth. Evident though is still a sparseness of development around and within the campus. Jess Ranch (upper left) is still a working ranch. There are more empty lots than houses in the Spring Valley Lake development (bottom). The 33 acres (center right) is undeveloped and Bear Valley road is still a two lane highway. VVC with the exception of the PAC and Administration Building, under construction, is still largely unchanged from its original 1962 master plan.

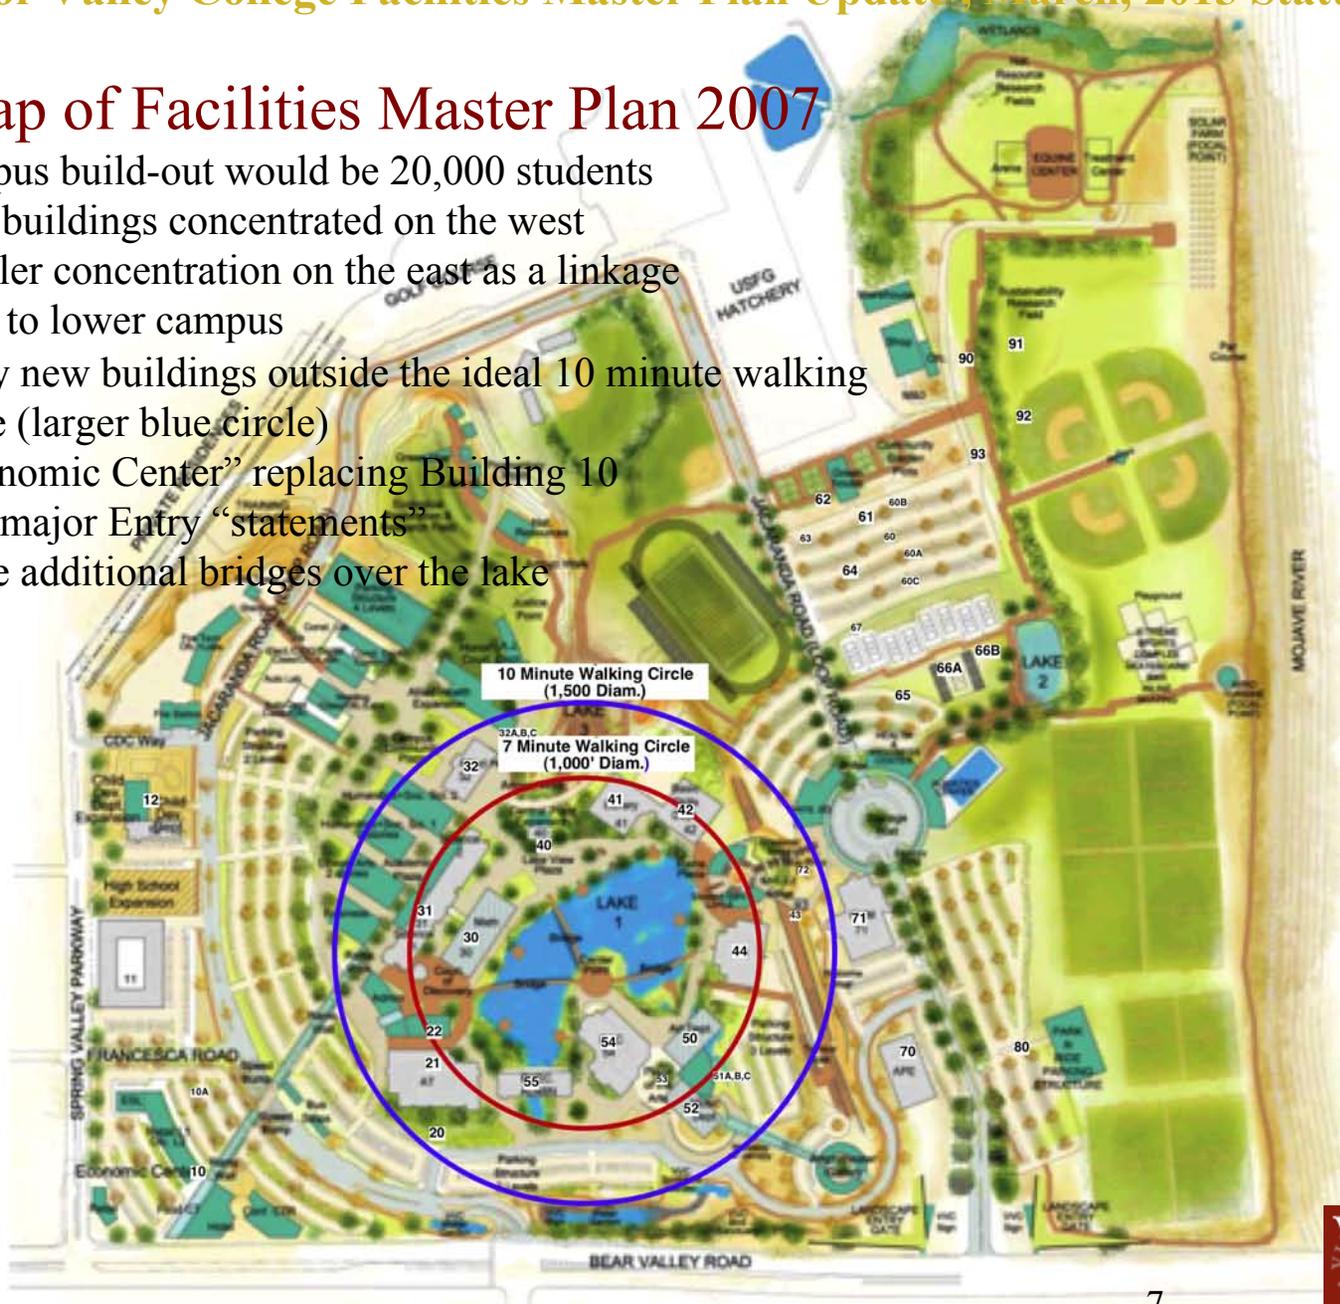
Victor Valley College Facilities Master Plan 2007

- Campus build-out would be 20,000 students
- New buildings concentrated on the west
- Smaller concentration on the east as a linkage to lower campus
- Many new buildings outside the ideal 10 minute walking circle (larger blue circle)
- “Economic Center” replacing Building 10
- Two major Entry “statements”
- Three additional bridges over the lake

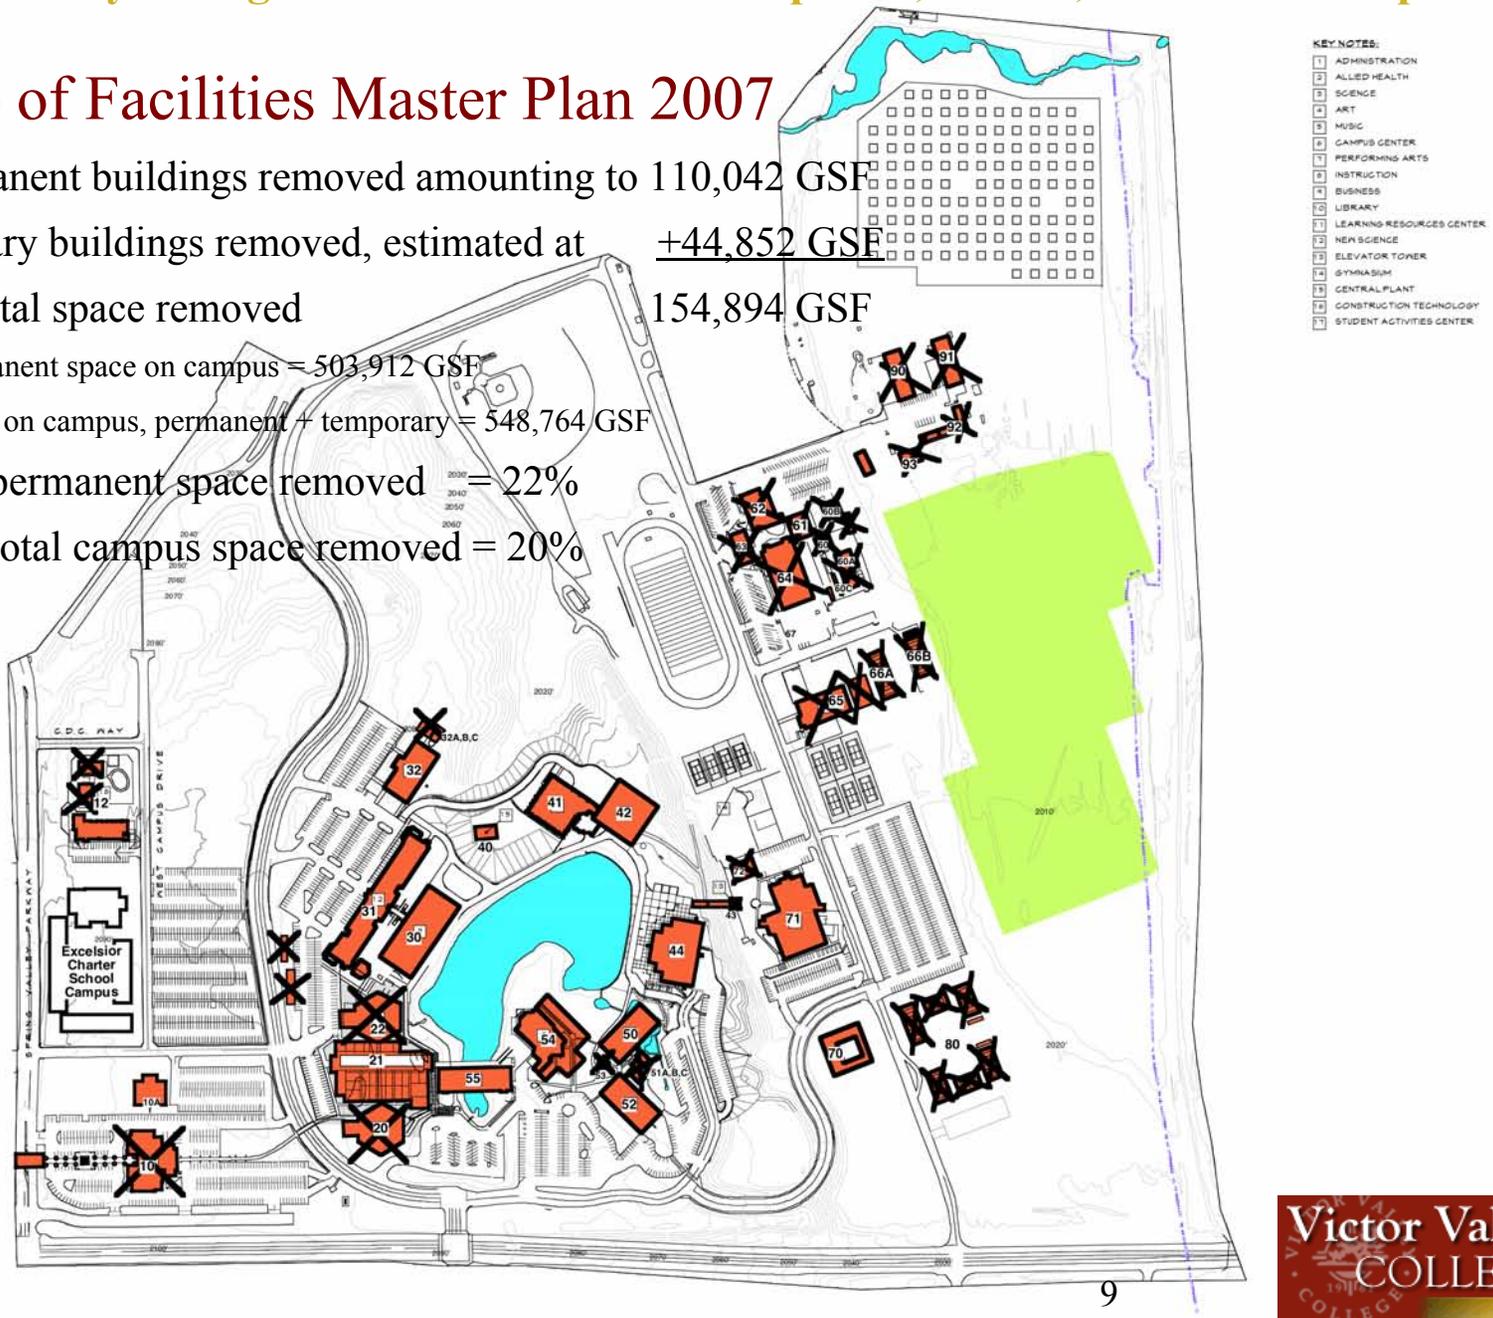
- 16 permanent buildings removed amounting to 110,042 GSF
- Temporary buildings removed, estimated at +44,852 GSF
- Grand total space removed 154,894 GSF
- Total permanent space on campus = 503,912 GSF
- Total space on campus, permanent + temporary = 548,764 GSF
- Percent permanent space removed = 22%
- Percent total campus space removed = 20%

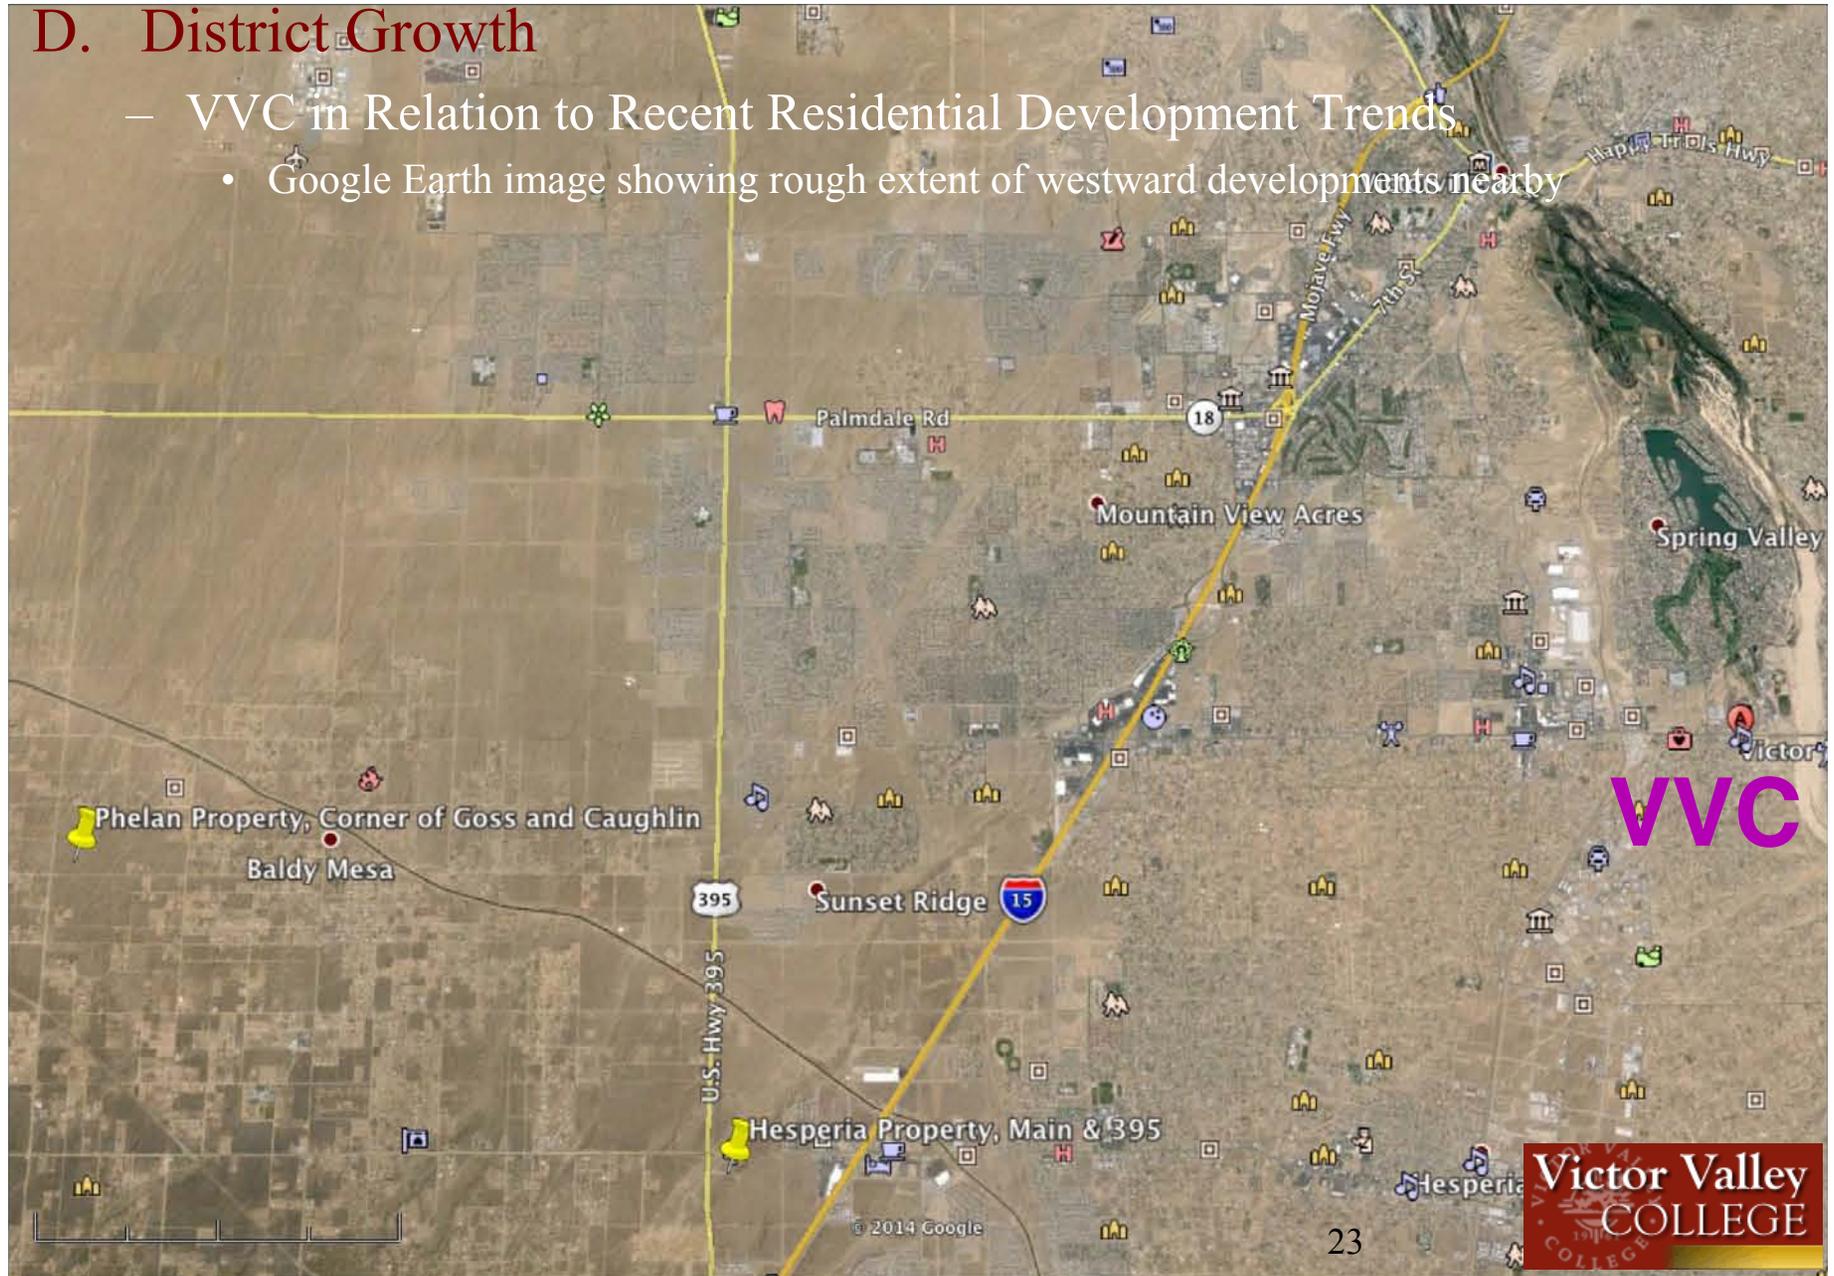
- VVC in Relation to Recent Residential Development Trends
 - Google Earth image showing rough extent of westward developments nearby

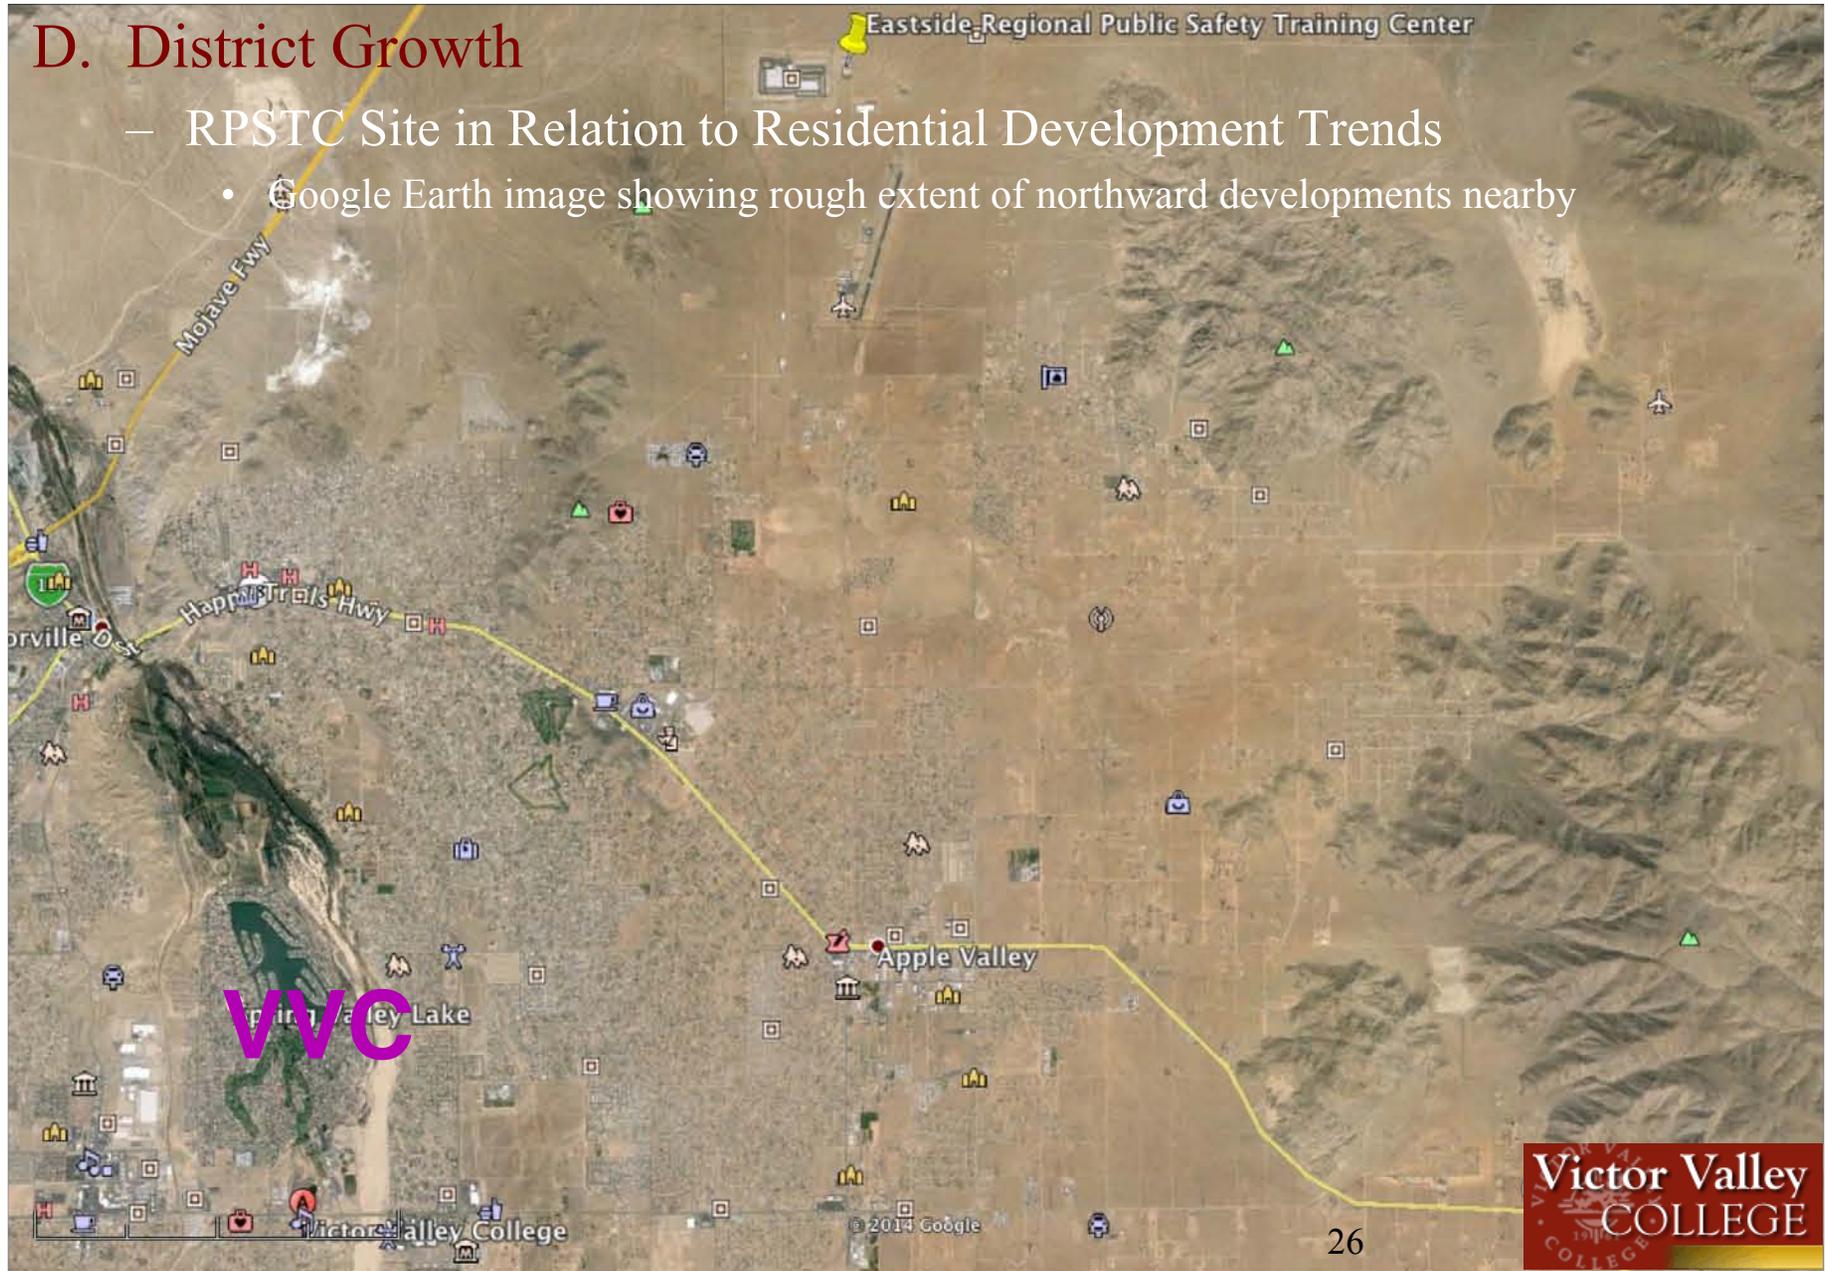
- RPSTC Site in Relation to Residential Development Trends
 - Google Earth image showing rough extent of northward developments nearby

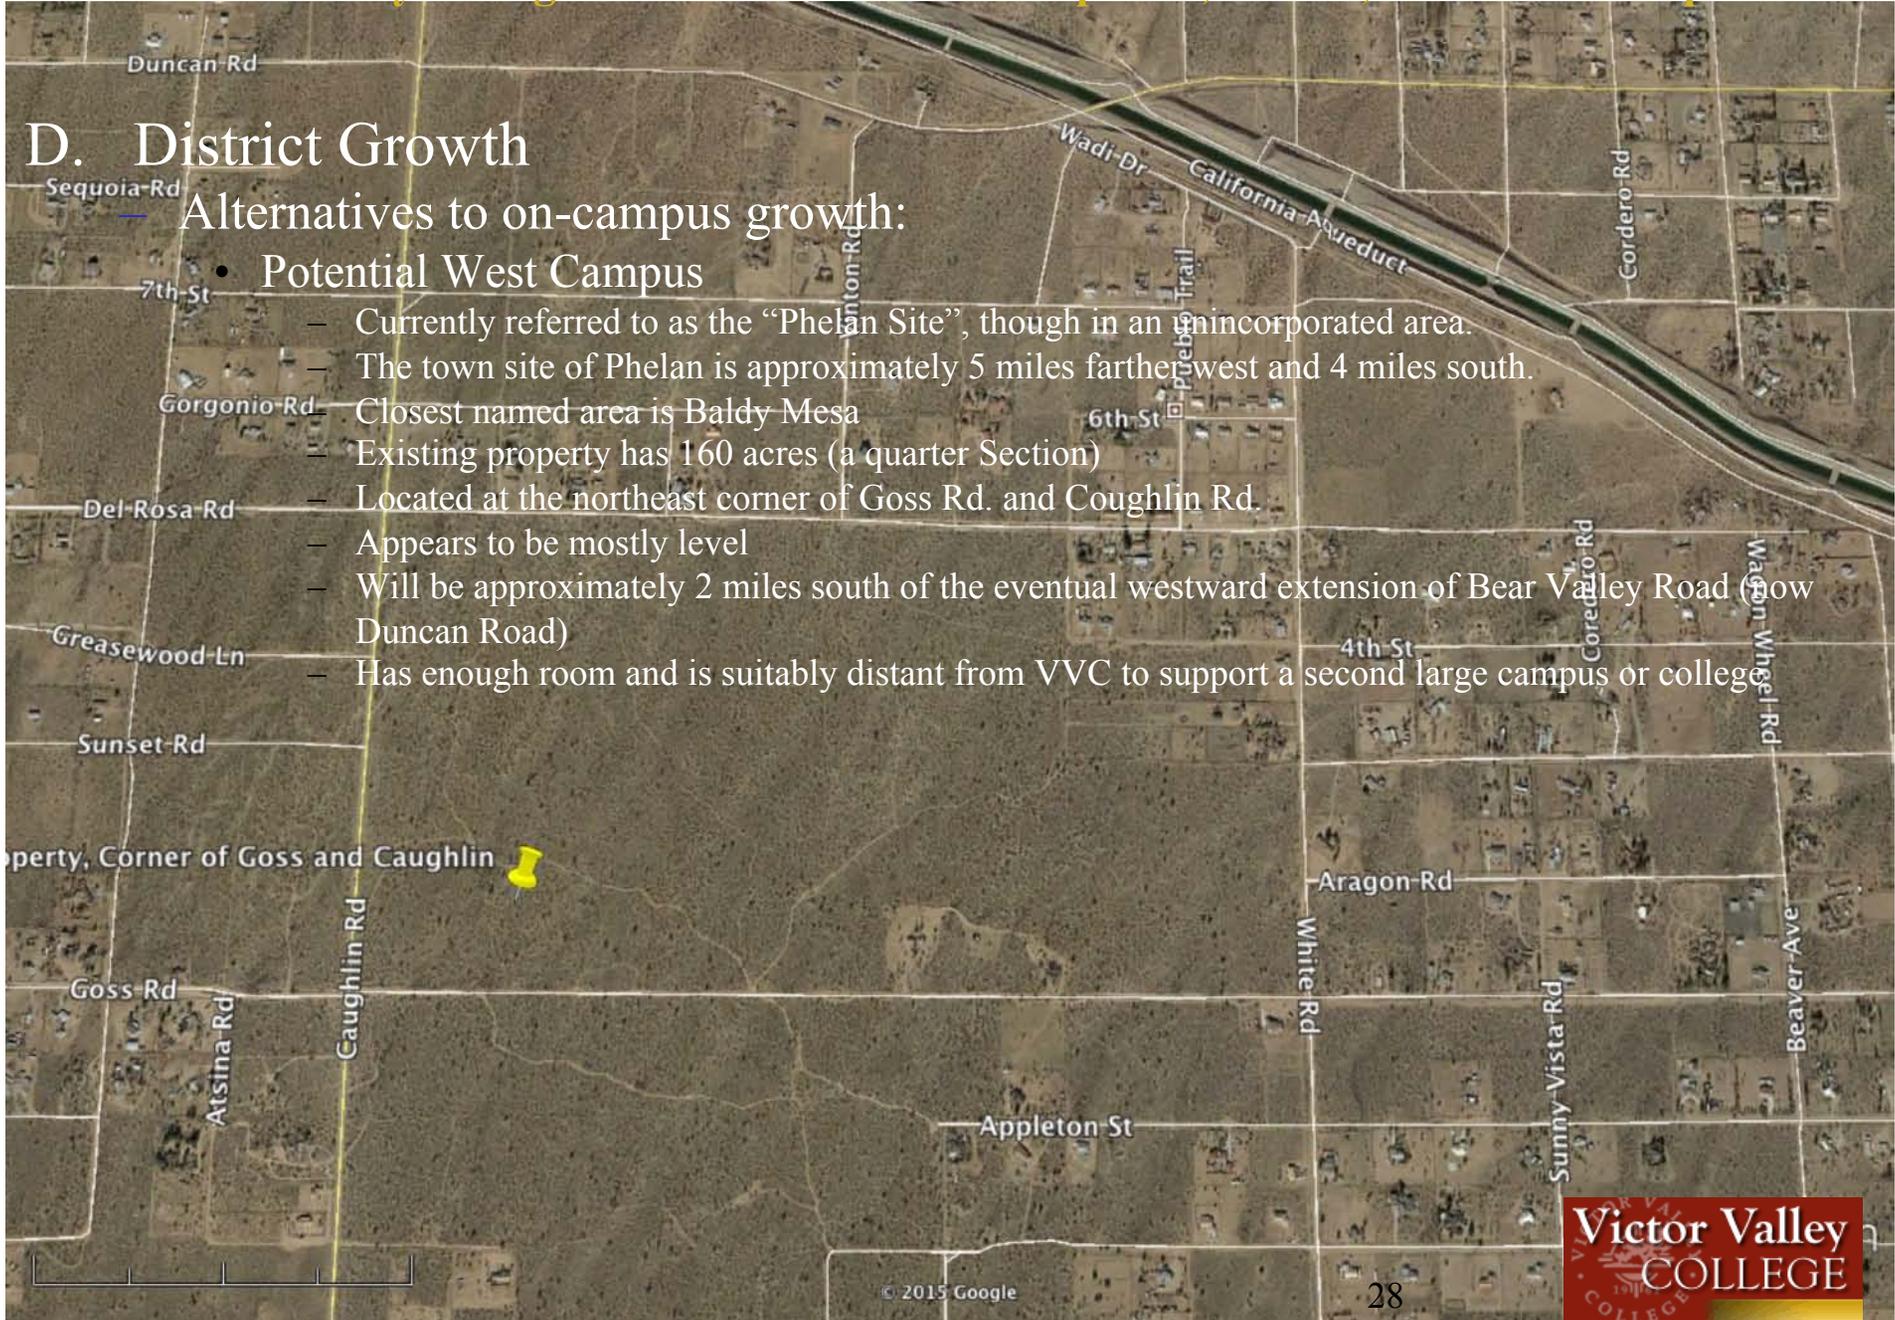
Property, Corner of Goss and Caughlin

- Currently referred to as the “Phelan Site”, though in an unincorporated area.
- The town site of Phelan is approximately 5 miles farther west and 4 miles south.
- Closest named area is Baldy Mesa
- Existing property has 160 acres (a quarter Section)
- Located at the northeast corner of Goss Rd. and Coughlin Rd.
- Appears to be mostly level
- Will be approximately 2 miles south of the eventual westward extension of Bear Valley Road (now Duncan Road)
- Has enough room and is suitably distant from VVC to support a second large campus or college

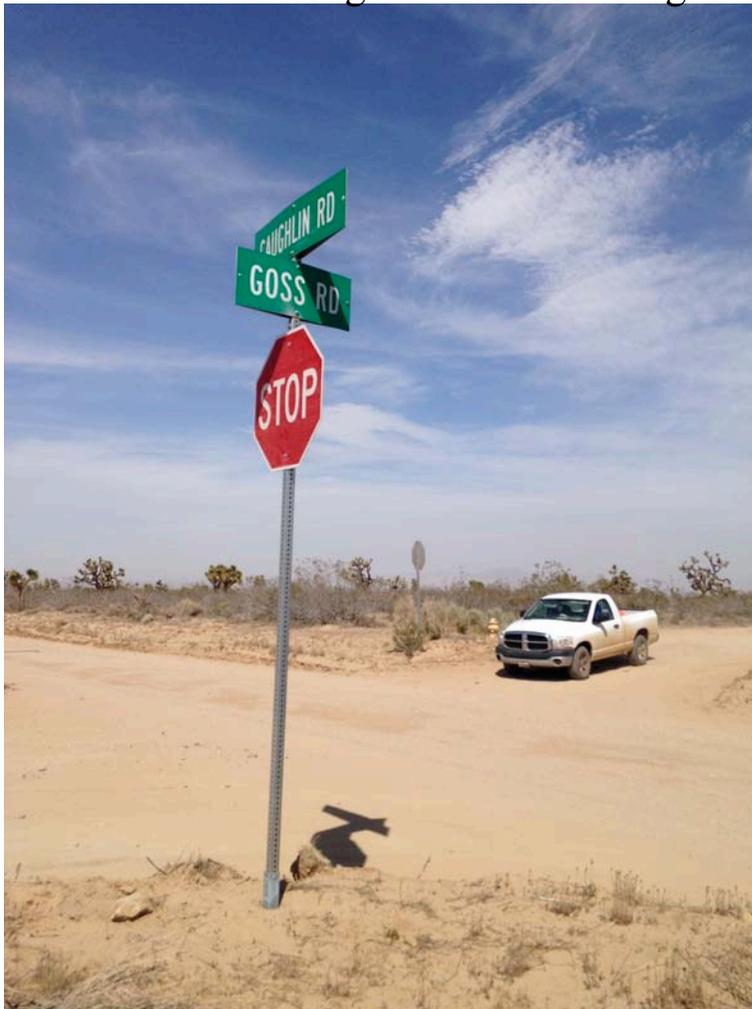
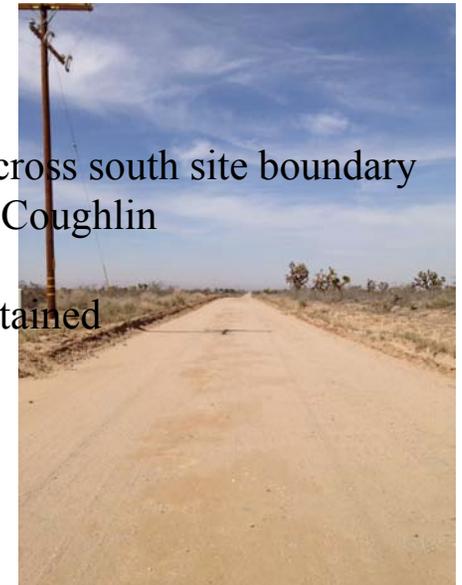
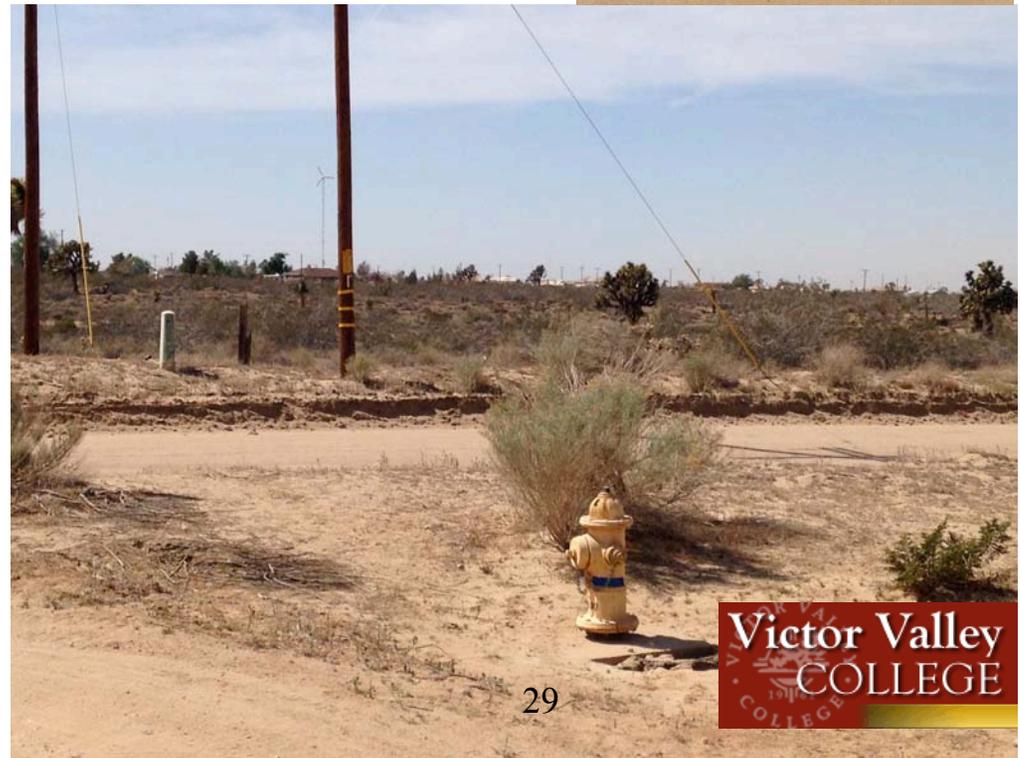
- Phelan Site at corner of Coughlin and Goss roads
 - Fire hydrants (presumably water service) extend along Goss across south site boundary
 - Power and telecommunications in place at corner of Goss and Coughlin
 - Site mostly level and sloping to the north
 - Coughlin Road is well-graded; Goss Road is currently unmaintained

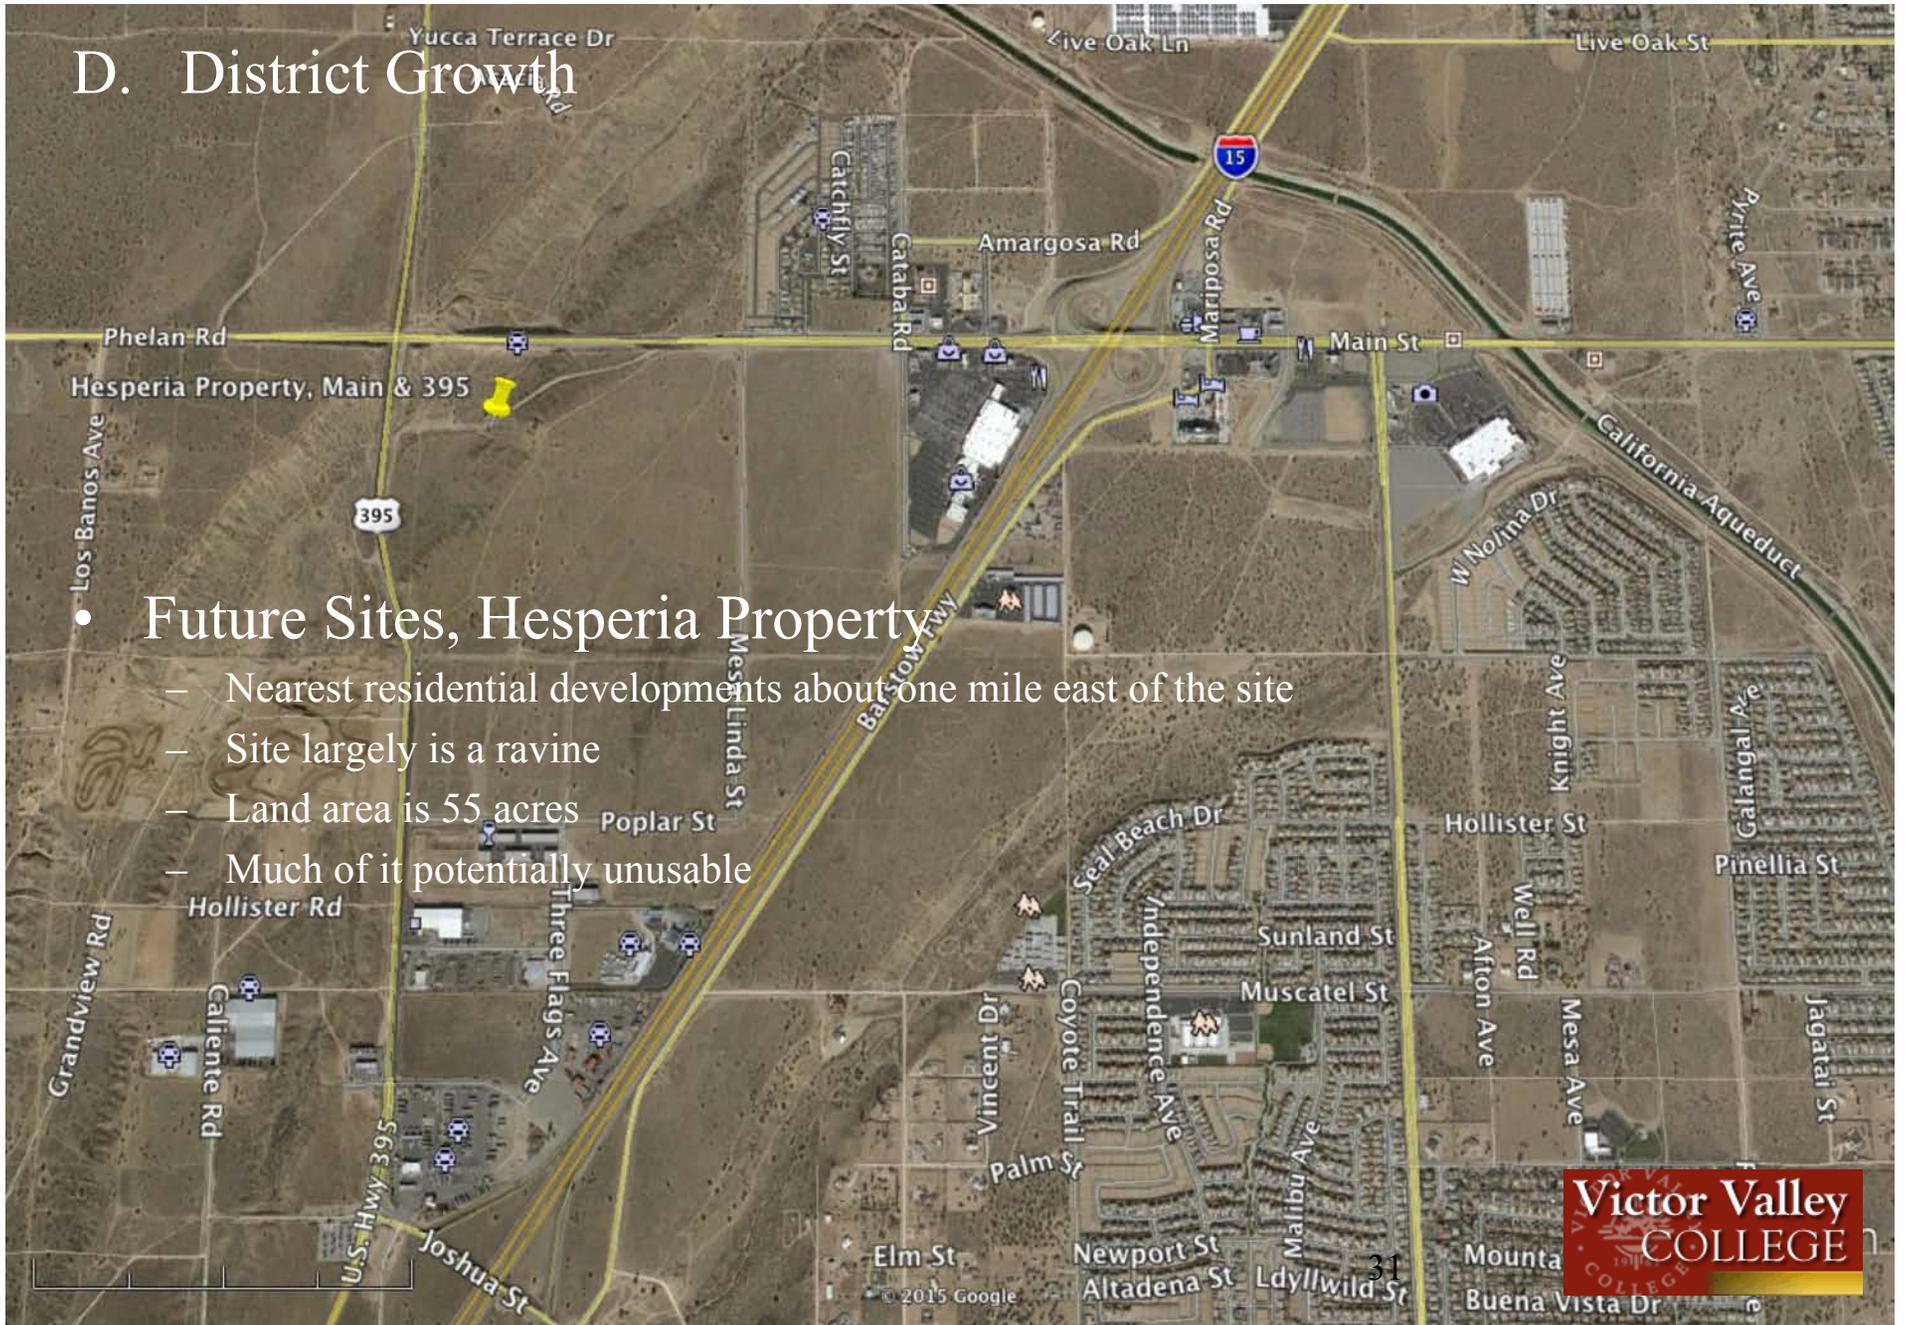
Future Sites, Hesperia Property

- Nearest residential developments about one mile east of the site
- Site largely is a ravine
- Land area is 55 acres
- Much of it potentially unusable

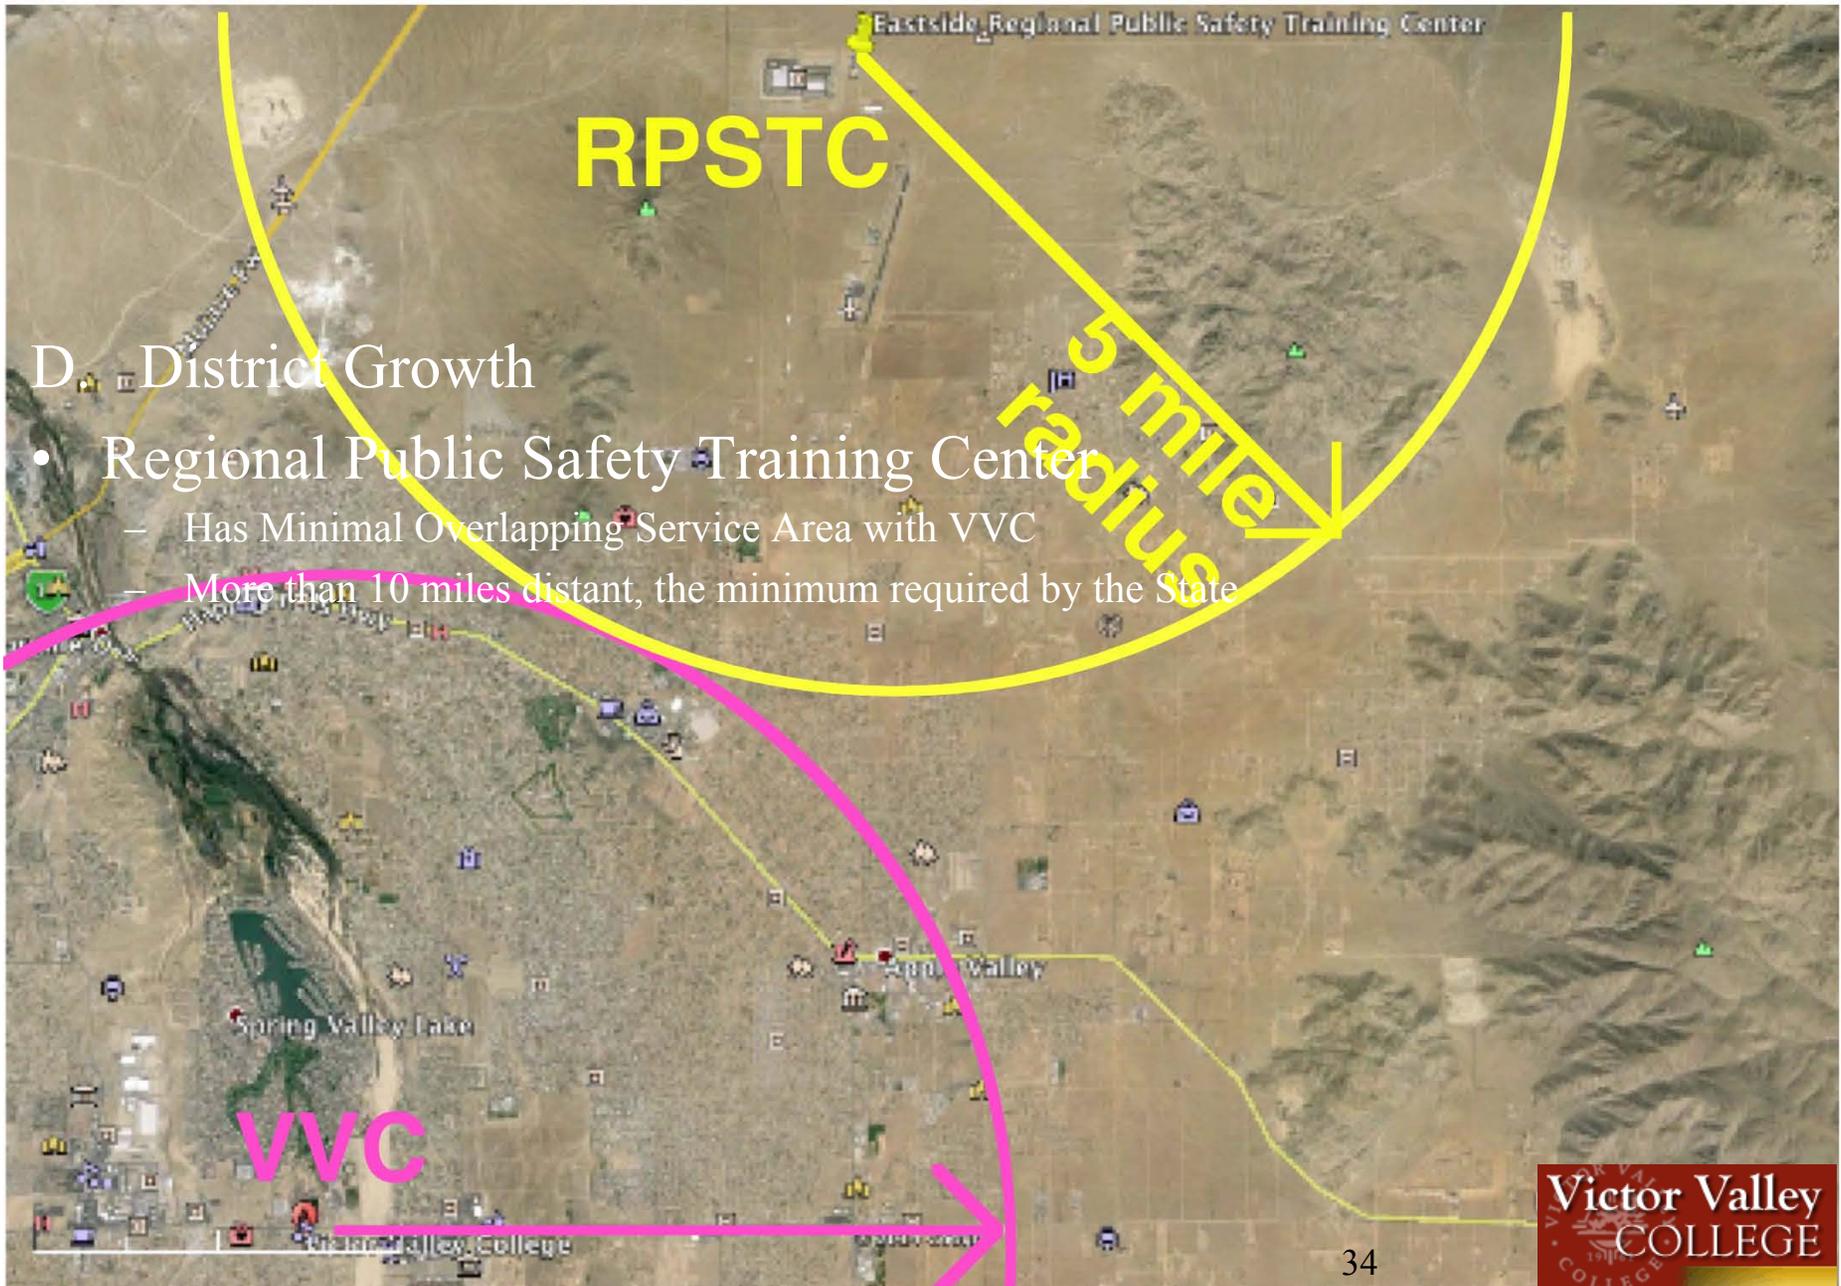
- Regional Public Safety Training Center
 - Has Minimal Overlapping Service Area with VVC
 - More than 10 miles distant, the minimum required by the State

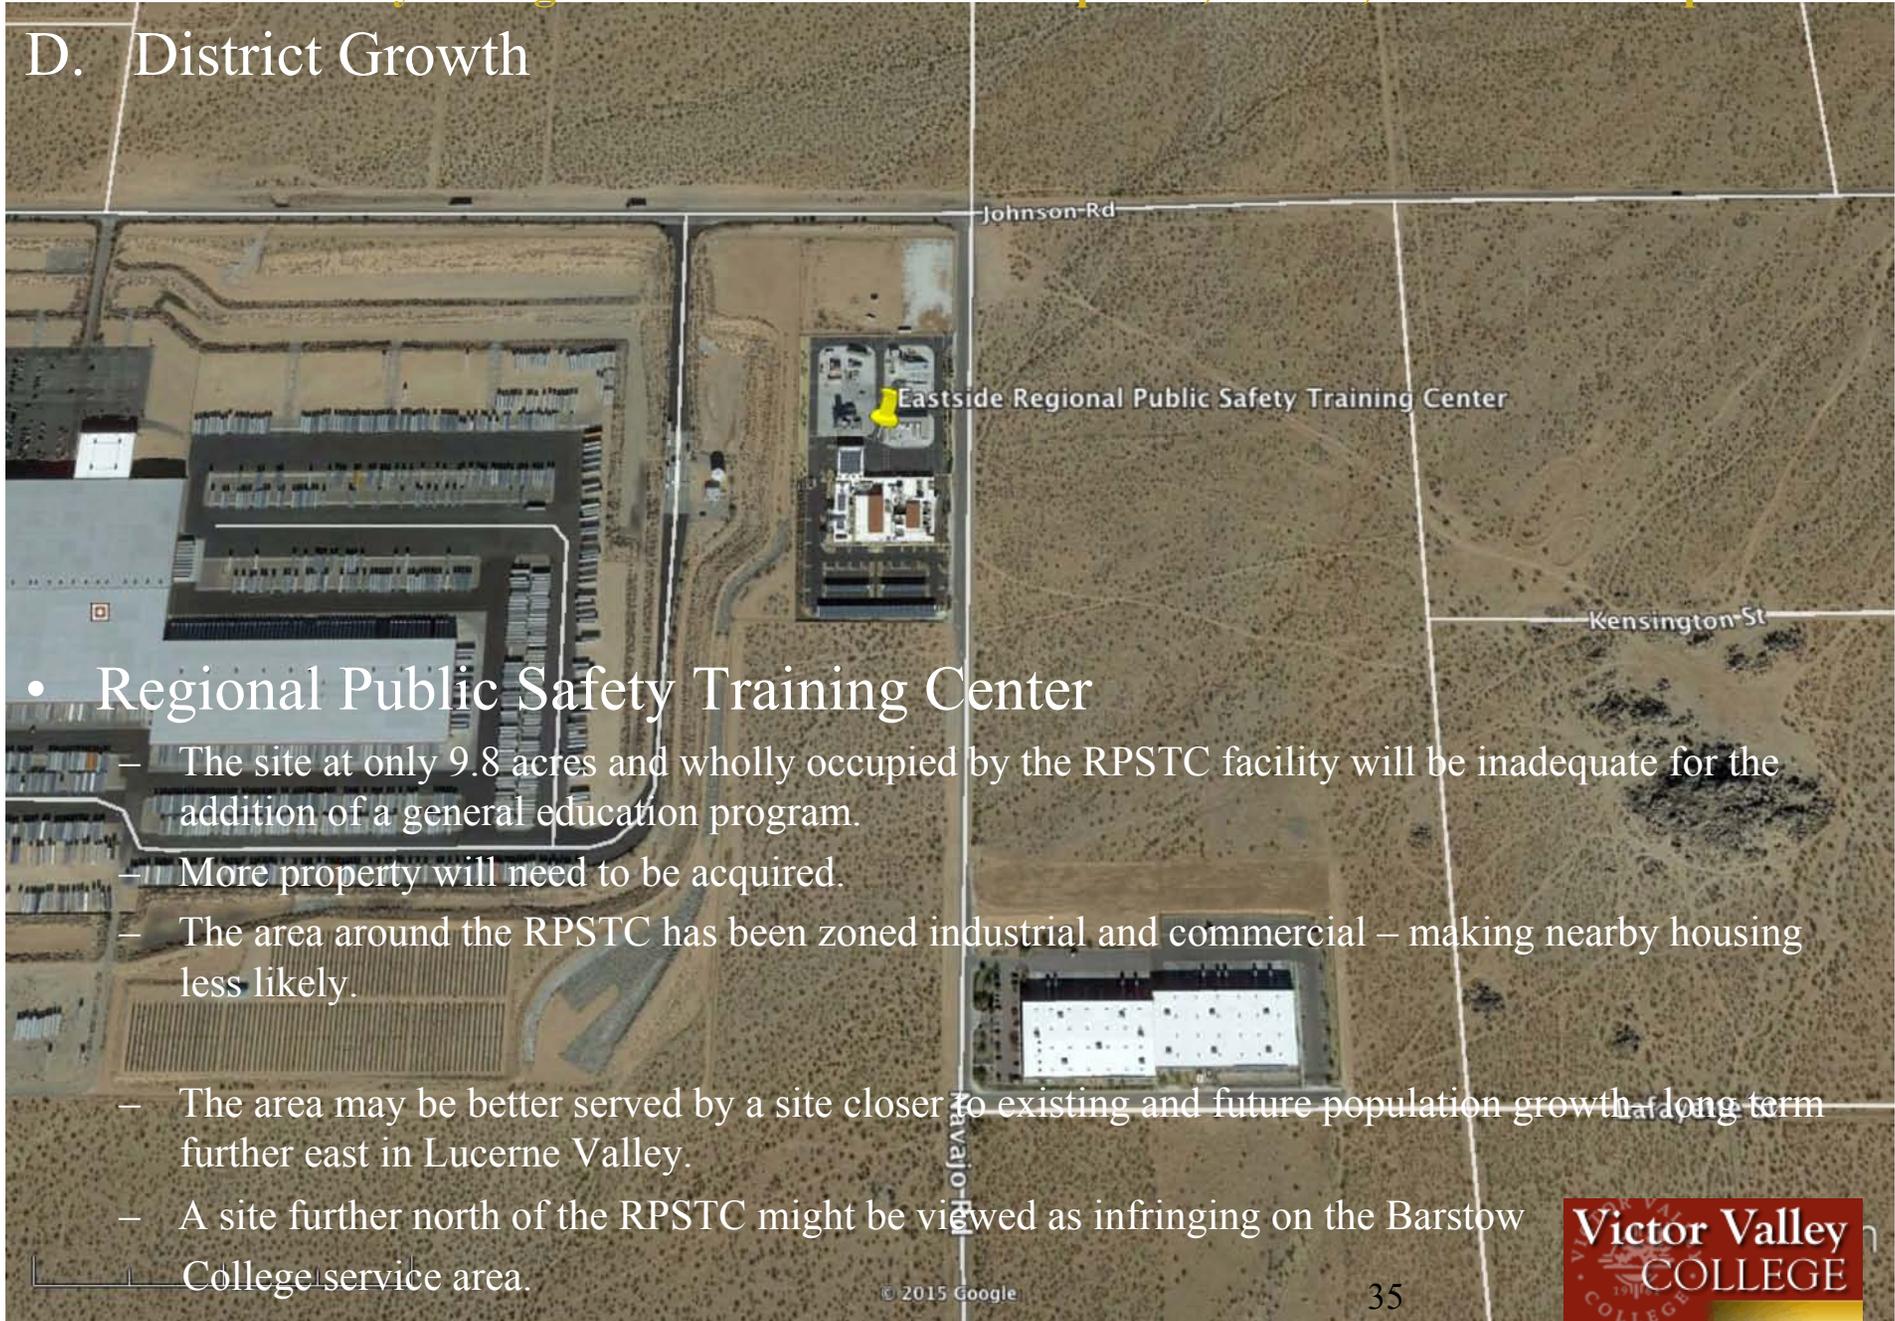
- Regional Public Safety Training Center

- The site at only 9.8 acres and wholly occupied by the RPSTC facility will be inadequate for the addition of a general education program.
- More property will need to be acquired.
- The area around the RPSTC has been zoned industrial and commercial – making nearby housing less likely.
- The area may be better served by a site closer to existing and future population growth, long term further east in Lucerne Valley.
- A site further north of the RPSTC might be viewed as infringing on the Barstow College service area.
