Victor Valley College 2015 Facilities Master Plan Update

Introduction

Victor Valley College Facilities Master Plan Update , March, 2015 Status Report

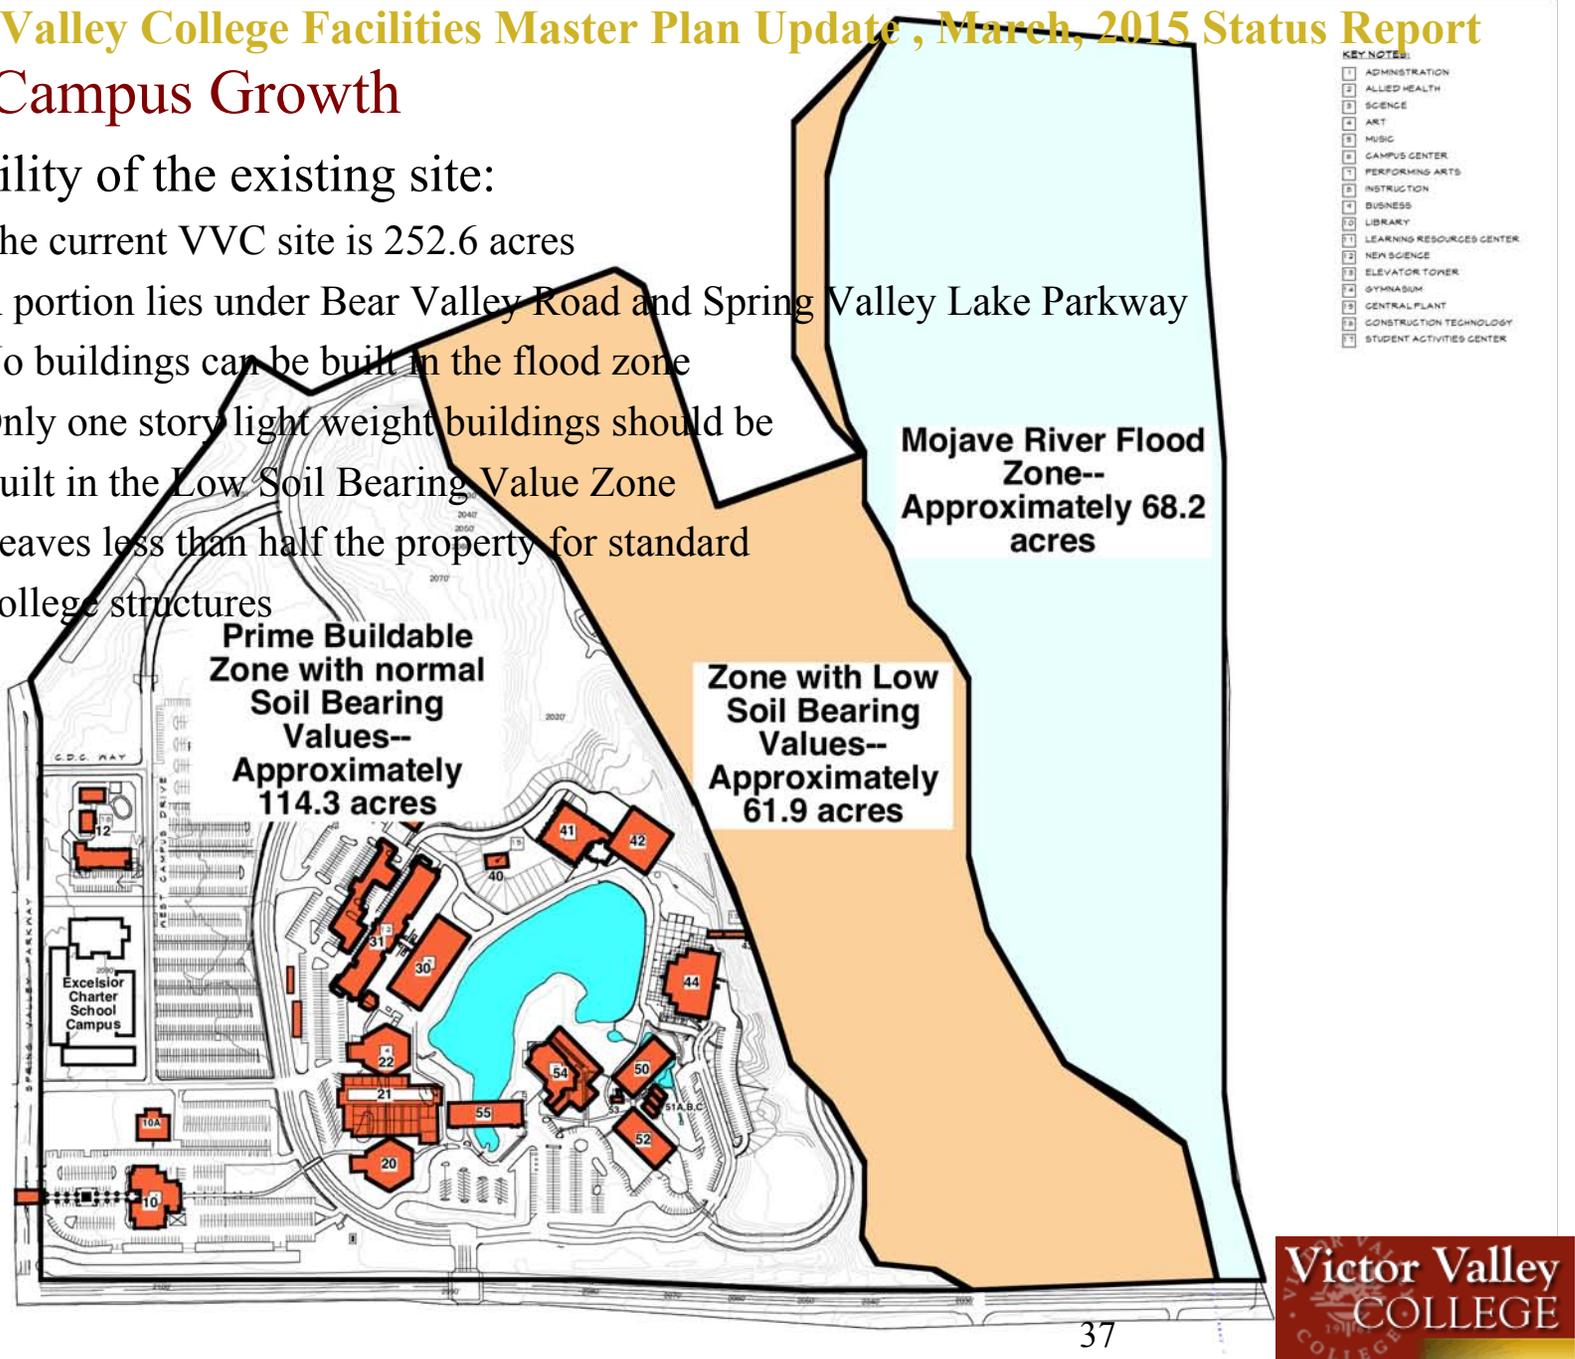
- The current VVC site is 252.6 acres
- A portion lies under Bear Valley Road and Spring Valley Lake Parkway
- No buildings can be built in the flood zone
- Only one story light weight buildings should be built in the Low Soil Bearing Value Zone
- Leaves less than half the property for standard college structures

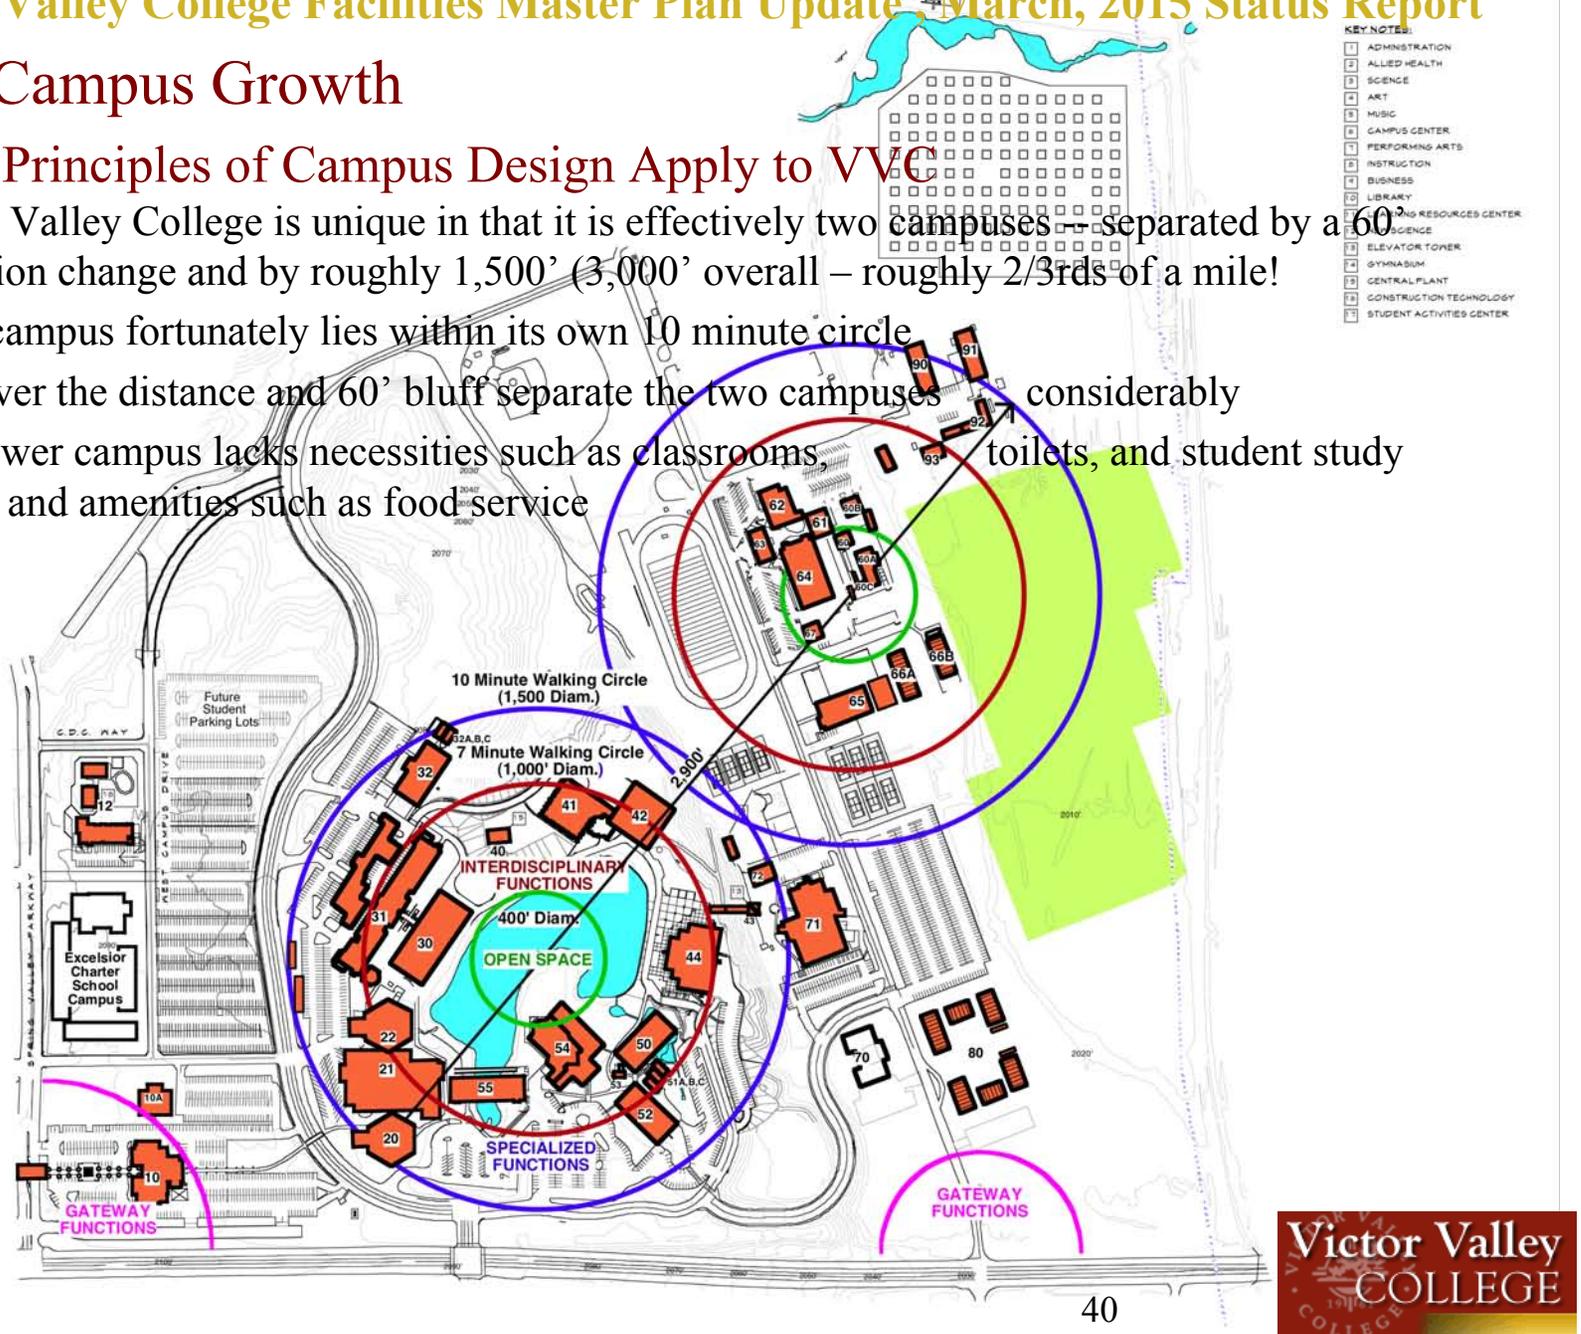
- How the Principles of Campus Design Apply to VVC
 - Victor Valley College is unique in that it is effectively two campuses – separated by a 60' elevation change and by roughly 1,500' (3,000' overall – roughly 2/3rds of a mile!
 - Each campus fortunately lies within its own 10 minute circle
 - However the distance and 60' bluff separate the two campuses considerably
 - The lower campus lacks necessities such as classrooms, toilets, and student study space, and amenities such as food service

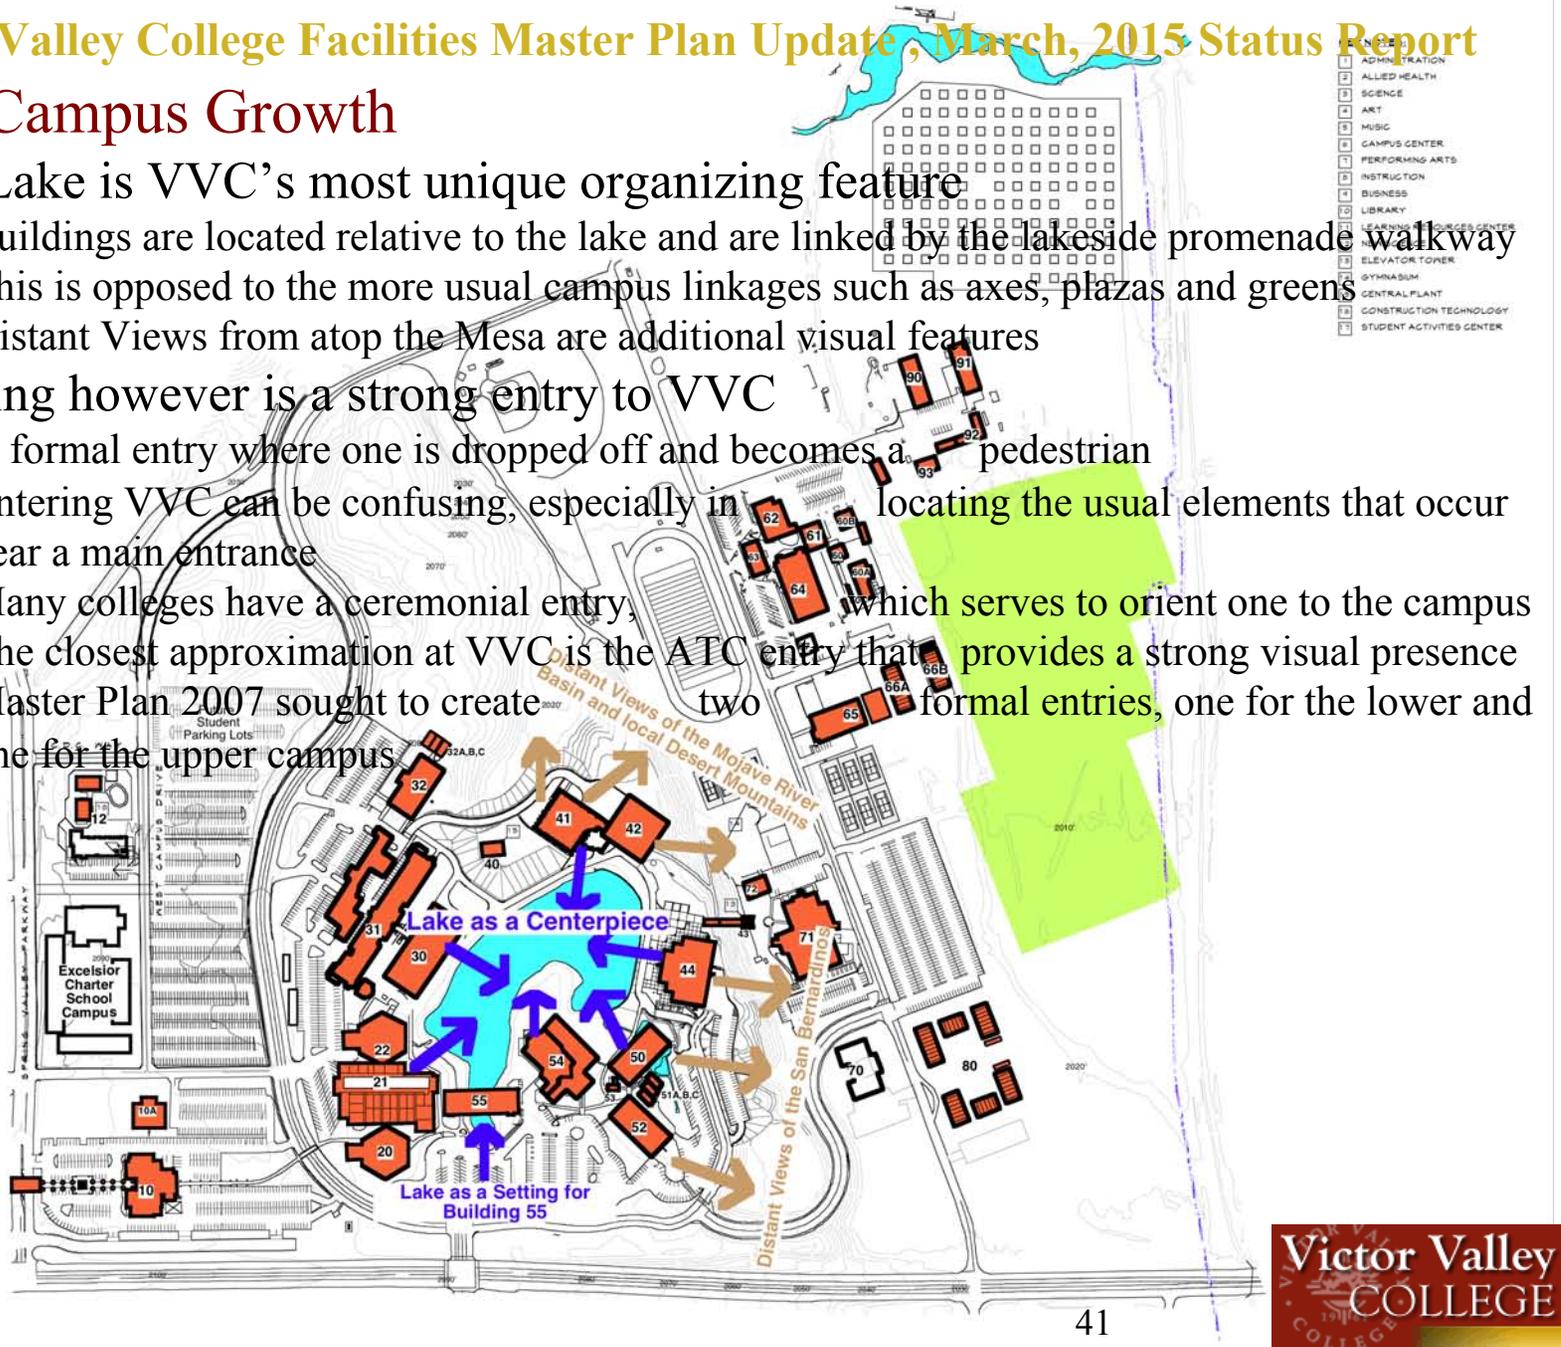
- The Lake is VVC's most unique organizing feature
 - Buildings are located relative to the lake and are linked by the lakeside promenade walkway
 - This is opposed to the more usual campus linkages such as axes, plazas and greens
 - Distant Views from atop the Mesa are additional visual features
- Missing however is a strong entry to VVC
 - A formal entry where one is dropped off and becomes a pedestrian
 - Entering VVC can be confusing, especially in locating the usual elements that occur near a main entrance
 - Many colleges have a ceremonial entry, which serves to orient one to the campus
 - The closest approximation at VVC is the ATC entry that provides a strong visual presence
 - Master Plan 2007 sought to create two formal entries, one for the lower and one for the upper campus

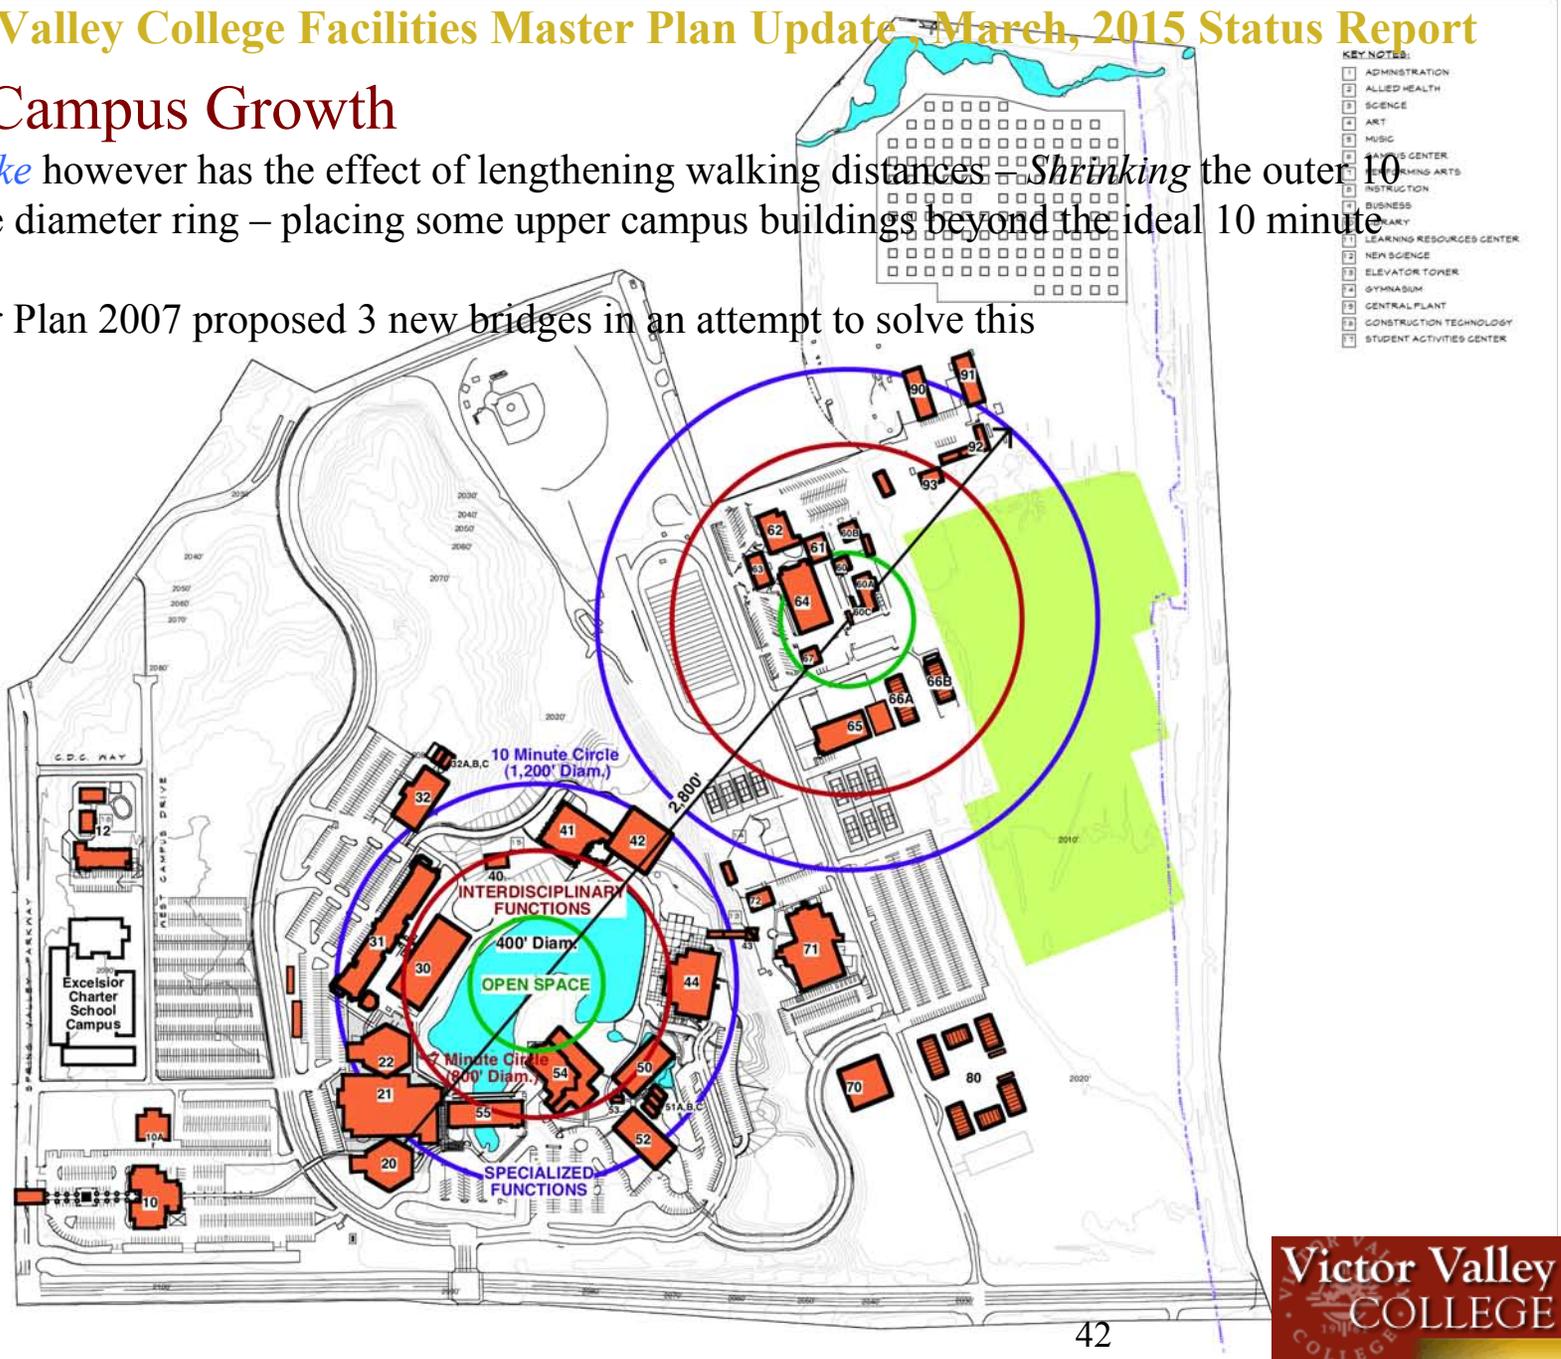
- The *lake* however has the effect of lengthening walking distances. *Shrinking* the outer 10 minute diameter ring – placing some upper campus buildings beyond the ideal 10 minute walk
- Master Plan 2007 proposed 3 new bridges in an attempt to solve this

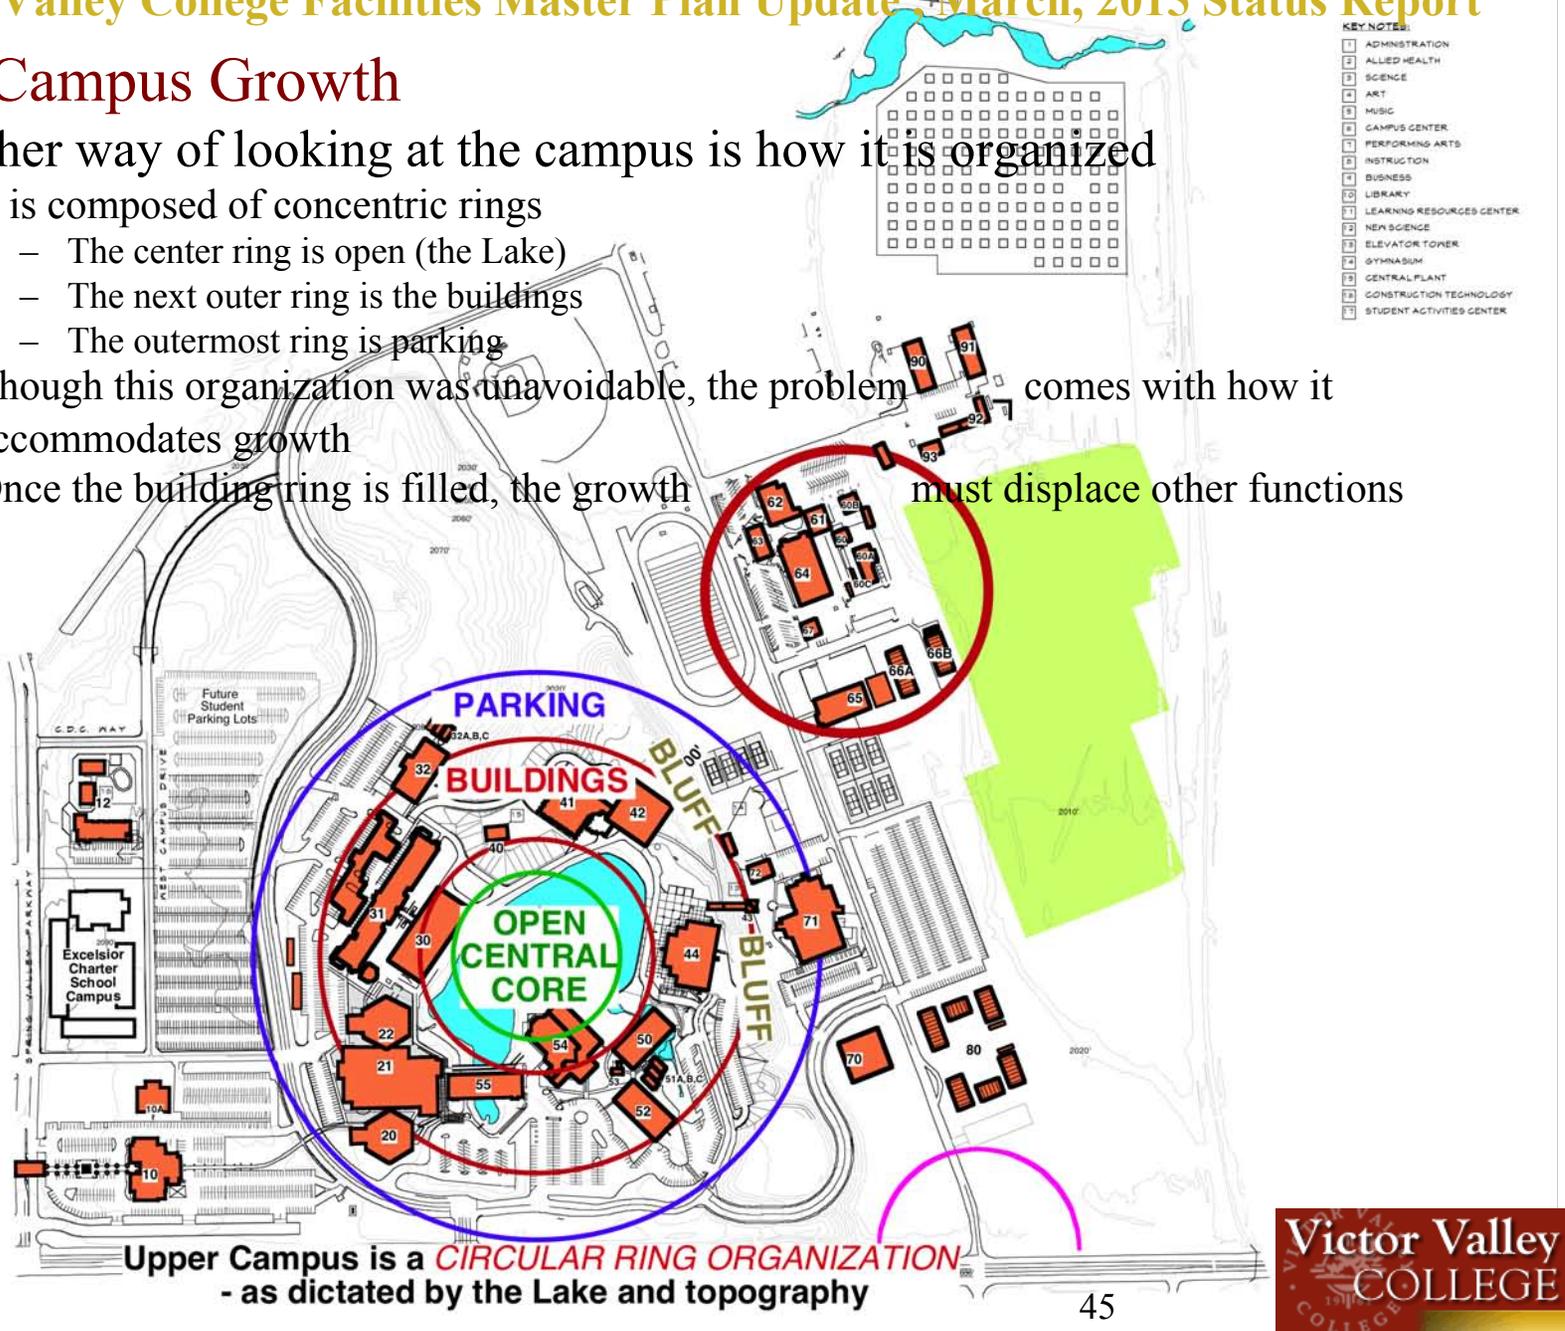
- Another way of looking at the campus is how it is organized
 - It is composed of concentric rings
 - The center ring is open (the Lake)
 - The next outer ring is the buildings
 - The outermost ring is parking
 - Though this organization was unavoidable, the problem comes with how it accommodates growth
 - Once the building ring is filled, the growth must displace other functions

Upper Campus is a **CIRCULAR RING ORGANIZATION**
- as dictated by the Lake and topography

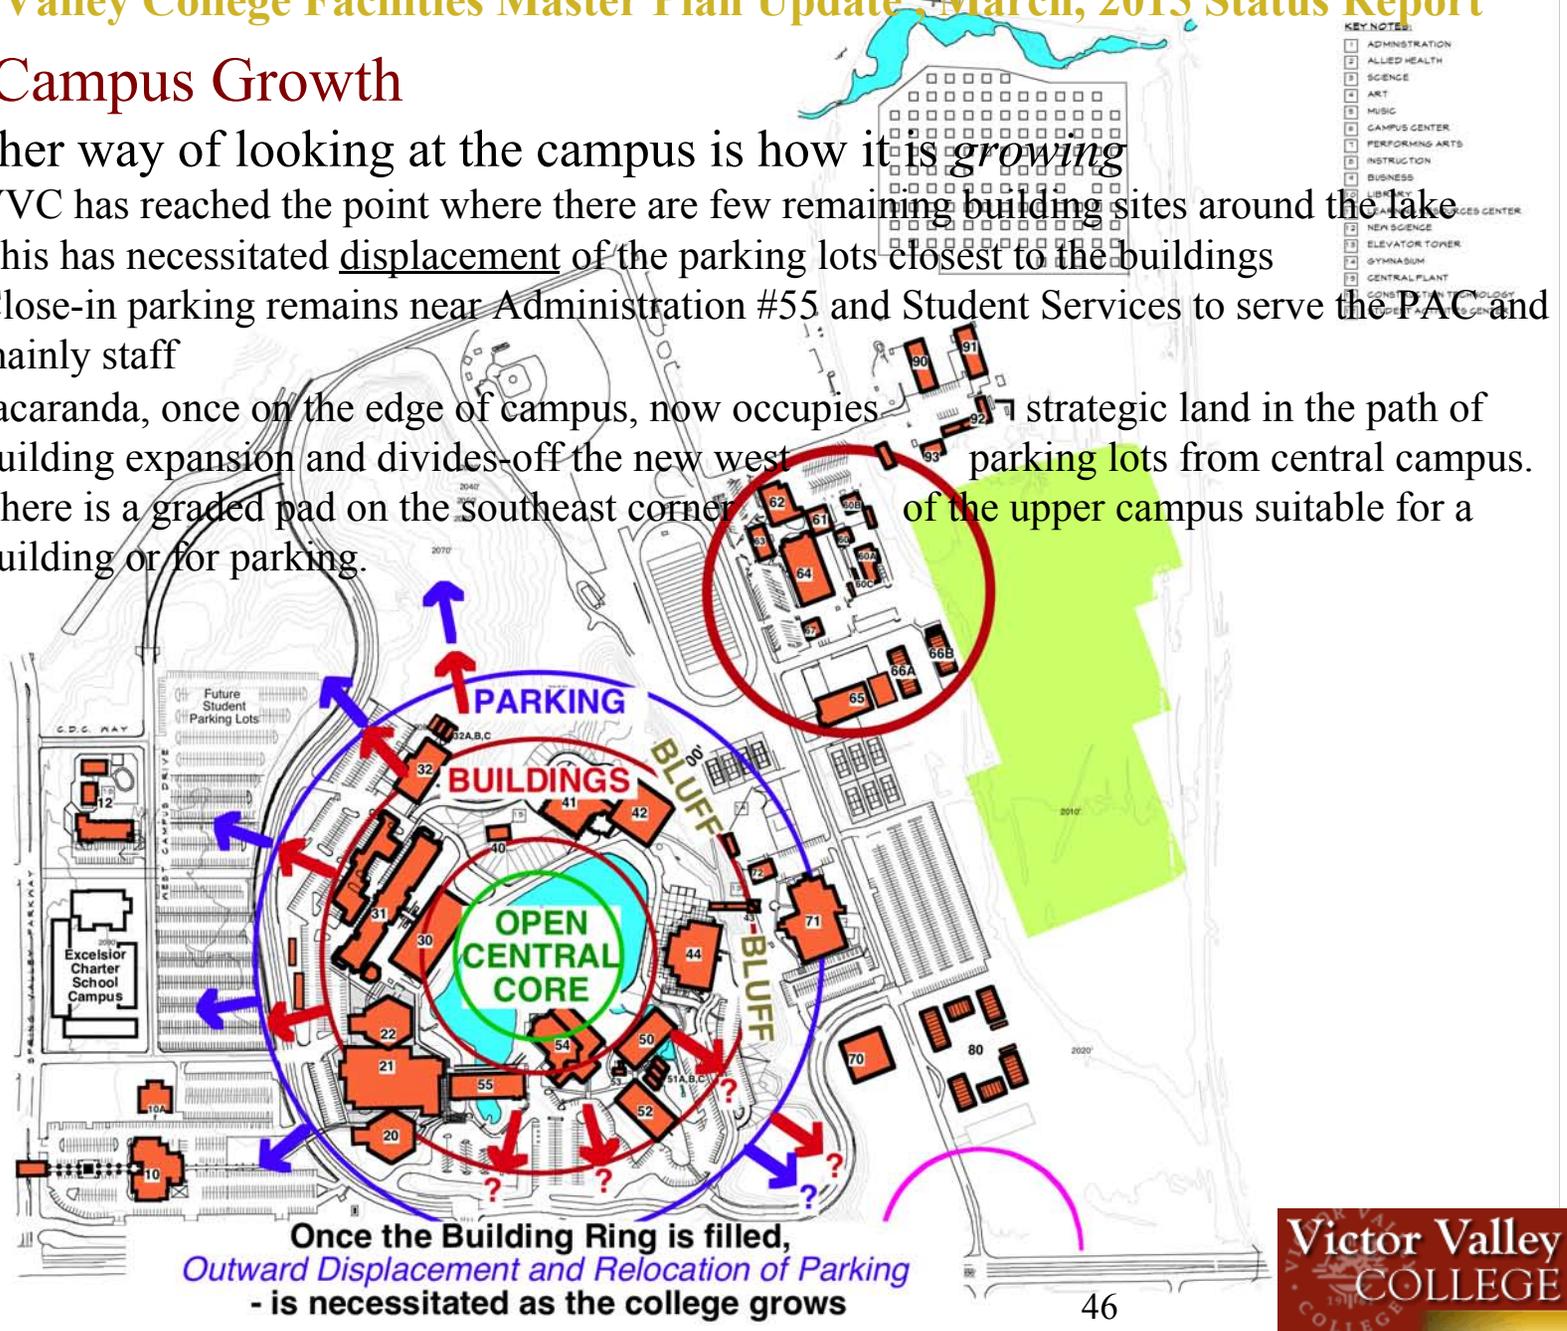
- Another way of looking at the campus is how it is *growing*
 - VVC has reached the point where there are few remaining building sites around the lake
 - This has necessitated displacement of the parking lots closest to the buildings
 - Close-in parking remains near Administration #55 and Student Services to serve the PAC and mainly staff
 - Jacaranda, once on the edge of campus, now occupies strategic land in the path of building expansion and divides-off the new west parking lots from central campus.
 - There is a graded pad on the southeast corner of the upper campus suitable for a building or for parking.

Once the Building Ring is filled,
Outward Displacement and Relocation of Parking
 - is necessitated as the college grows

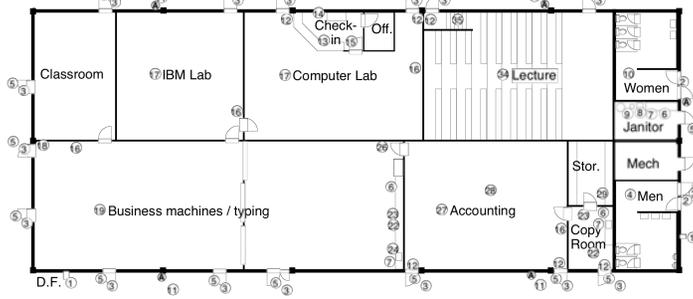
50 & 52 Before Conversion

- Recommended Plan, Reconvert 50 & 52 to Classrooms
 - Building 50 and 52 are identical in dimensions – 60’ wide x 150’ long. Each has 9,272 GSF. No fire sprinkling required. Area to be remodeled to classrooms and faculty offices = 18,544 GSF (including overhangs); toilets expanded at both; HVAC reconstruction is unlikely.
 - Estimated cost 18,544 GSF @ \$320/GSF*40% = \$2,400,000 x 1.25 site & soft costs = **\$3,000,000**
 - Alternative: limit toilet expansion to one building 9,272 GSF @ \$320/GSF*40% + 9,272 GSF @ \$320/GSF*25% = (\$1,200,000 + \$750,000) x 1.25 site & soft costs = **\$2,500,000**

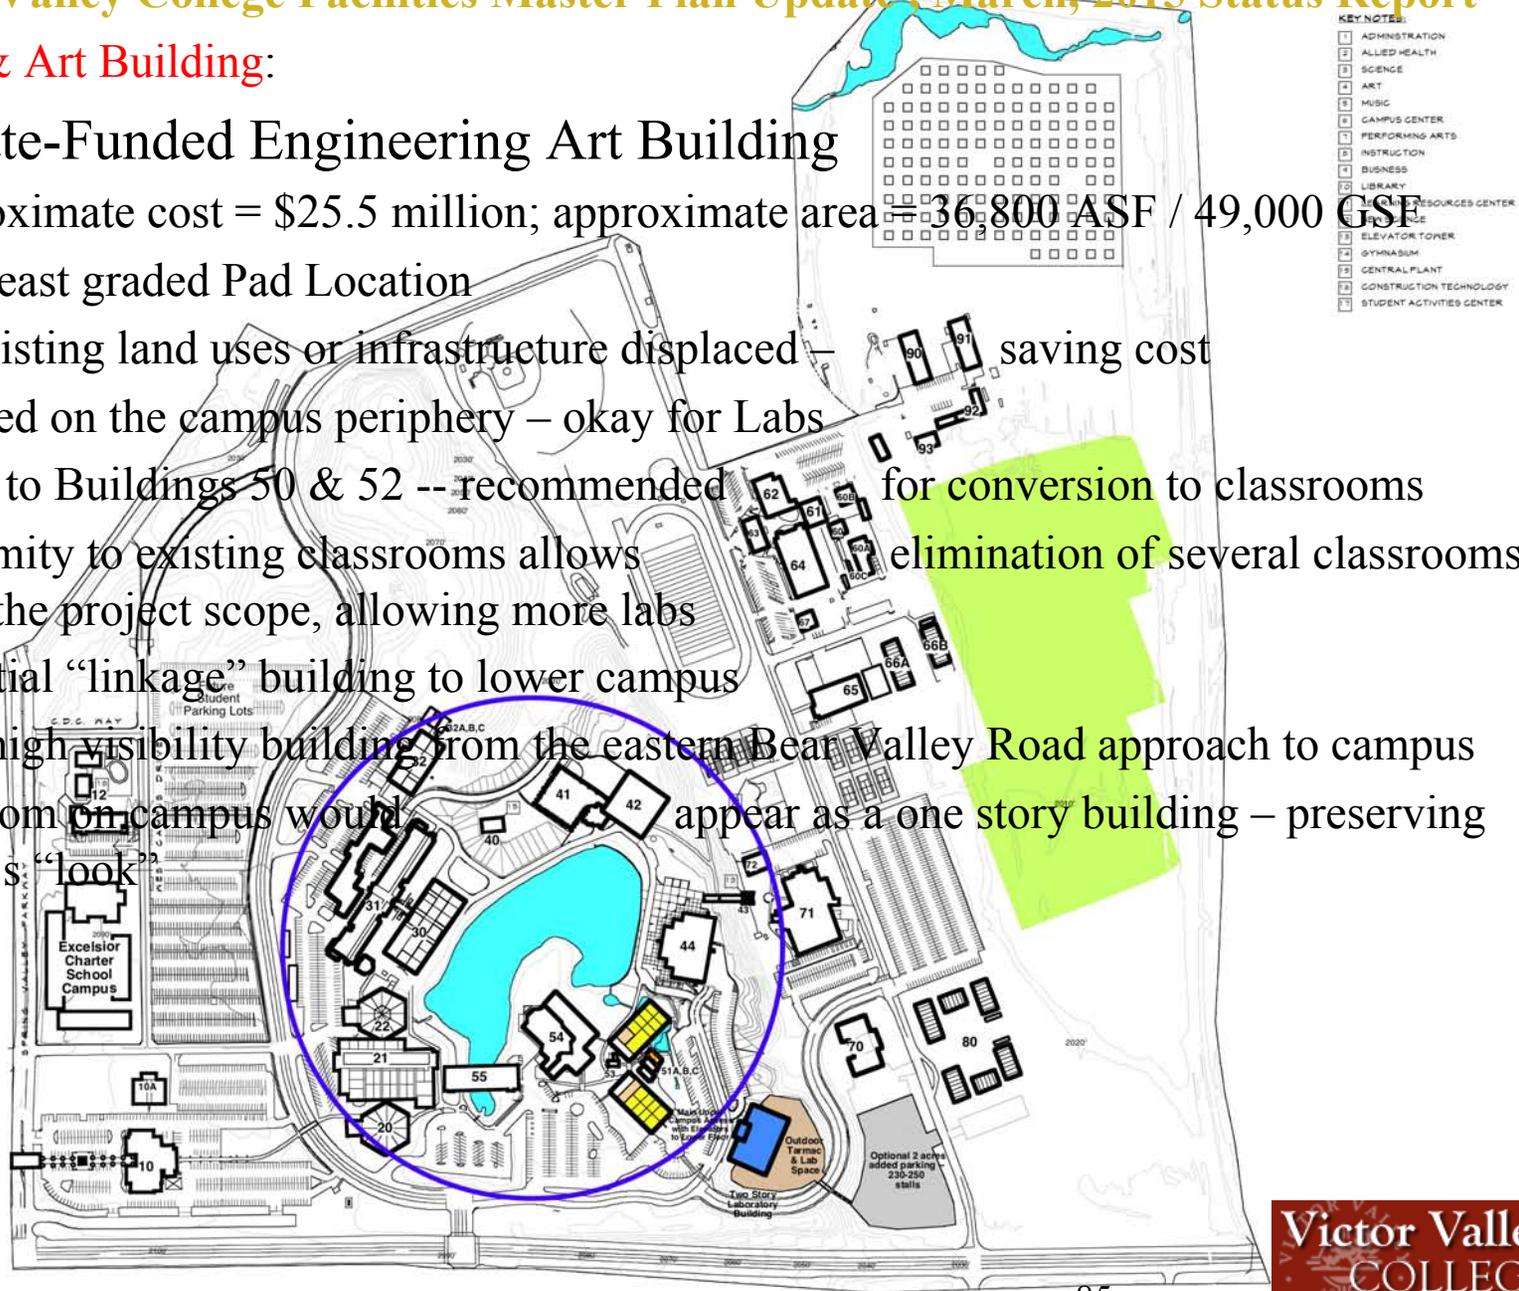
- **New State-Funded Engineering Art Building**
 - Approximate cost = \$25.5 million; approximate area = 36,800 ASF / 49,000 GSE
 - Southeast graded Pad Location
 - No existing land uses or infrastructure displaced – saving cost
 - Located on the campus periphery – okay for Labs
 - Close to Buildings 50 & 52 -- recommended for conversion to classrooms
 - Proximity to existing classrooms allows elimination of several classrooms from the project scope, allowing more labs
 - Potential “linkage” building to lower campus
 - First high visibility building from the eastern Bear Valley Road approach to campus
 - Yet from on campus would appear as a one story building – preserving VVC’s “look”
